Bi-annual Inspection Four Bridges One Culvert

**FOR THE
TOWNSHIP OF RED ROCK**

Ref. No. JML2023013

Reference: **Bi-Annual Inspection Four Bridges One Culvert**

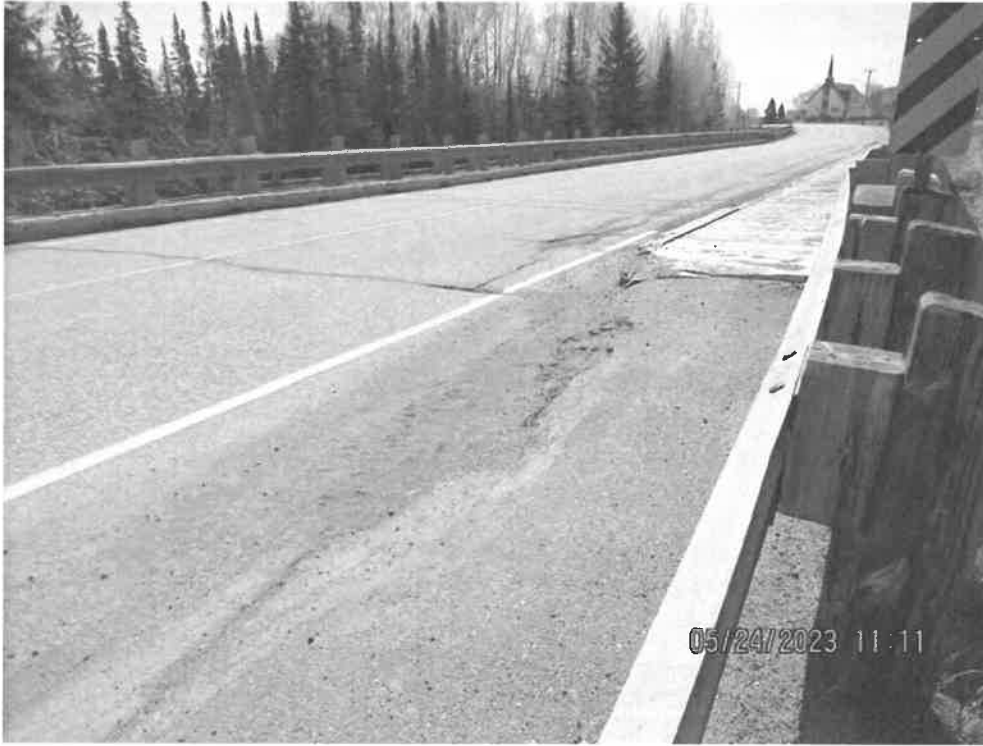
Photo 15: Impact damage at asphalt at north walkway approach.

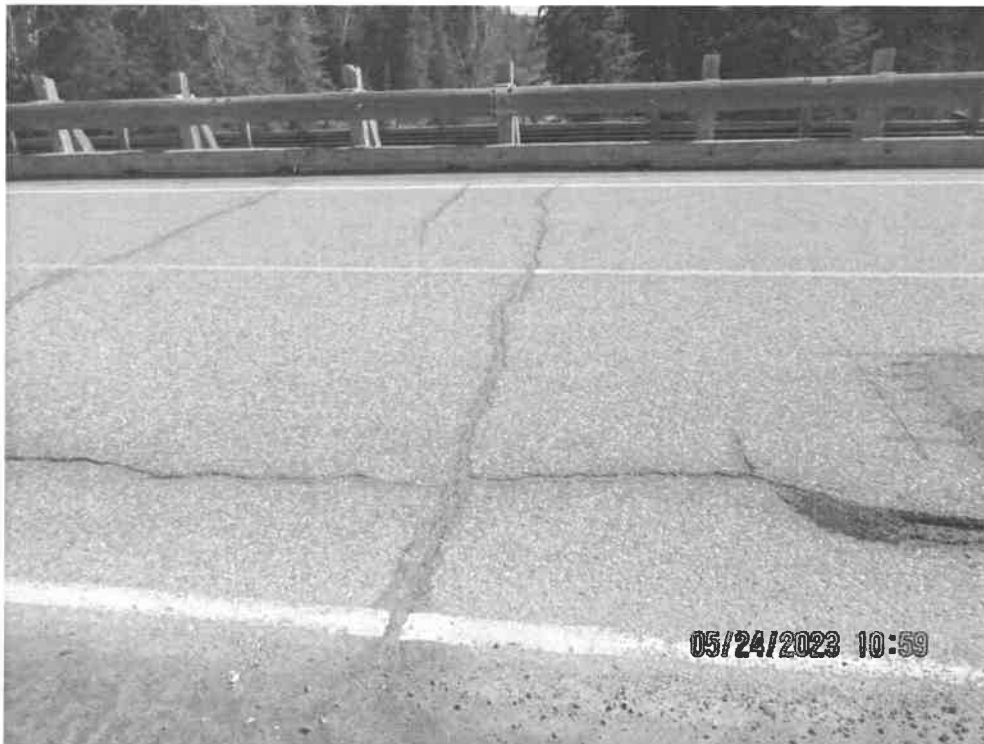
Photo 16: Severe transverse crack at asphalt wear surface (typ.).

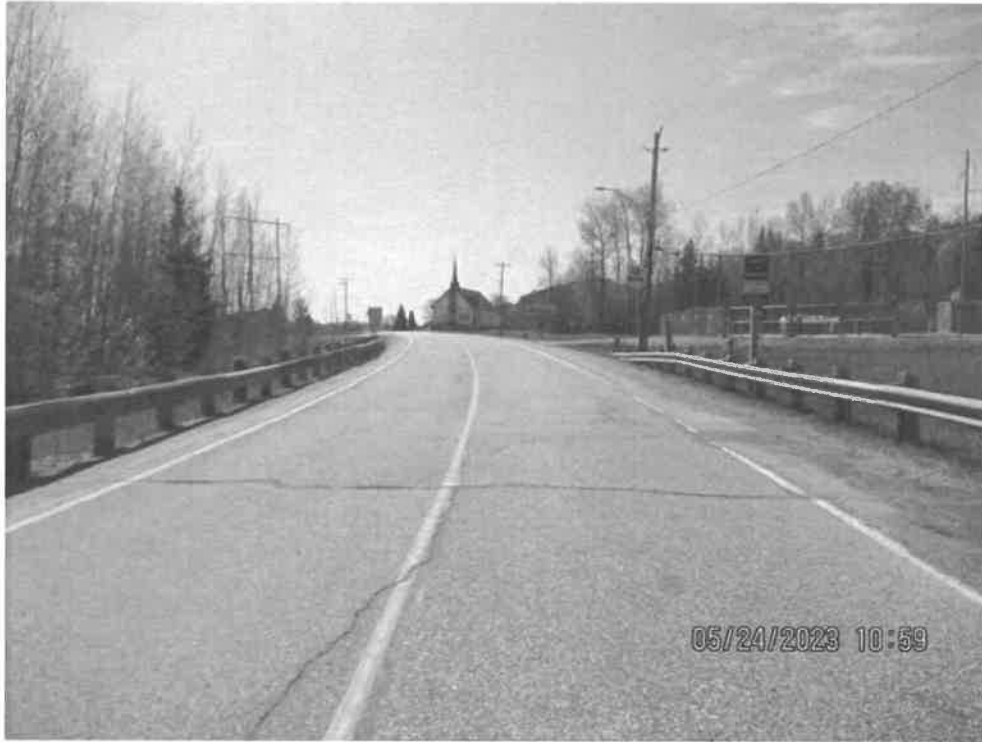
Photo 17: Medium longitudinal crack at south approach.

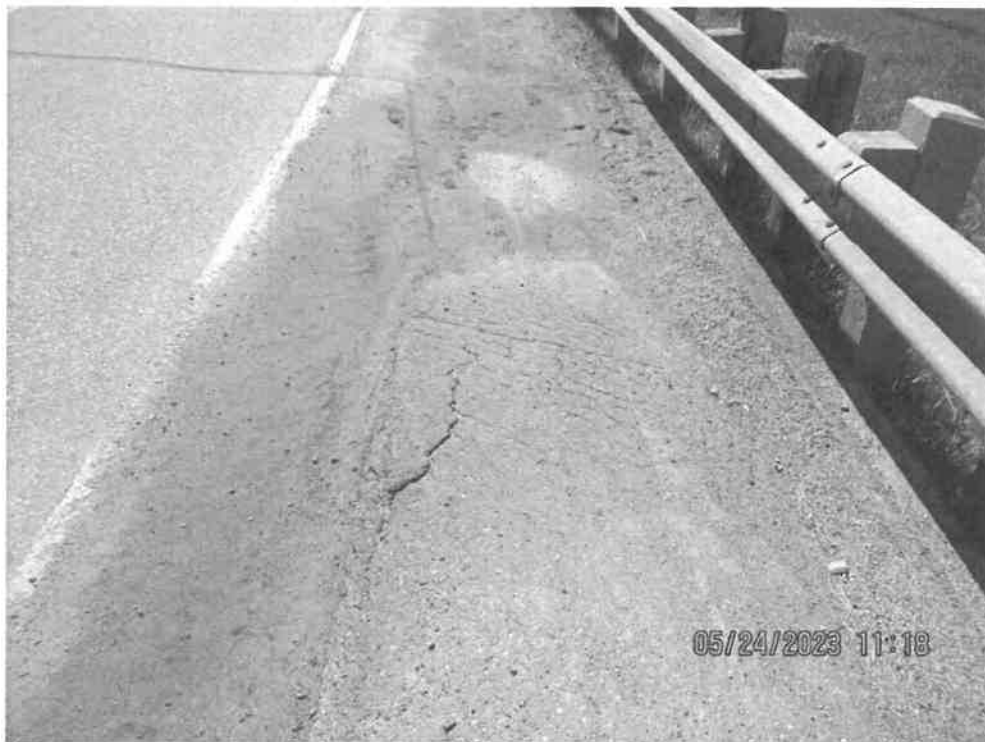
Photo 18: Medium cracking at pedestrian walkway.

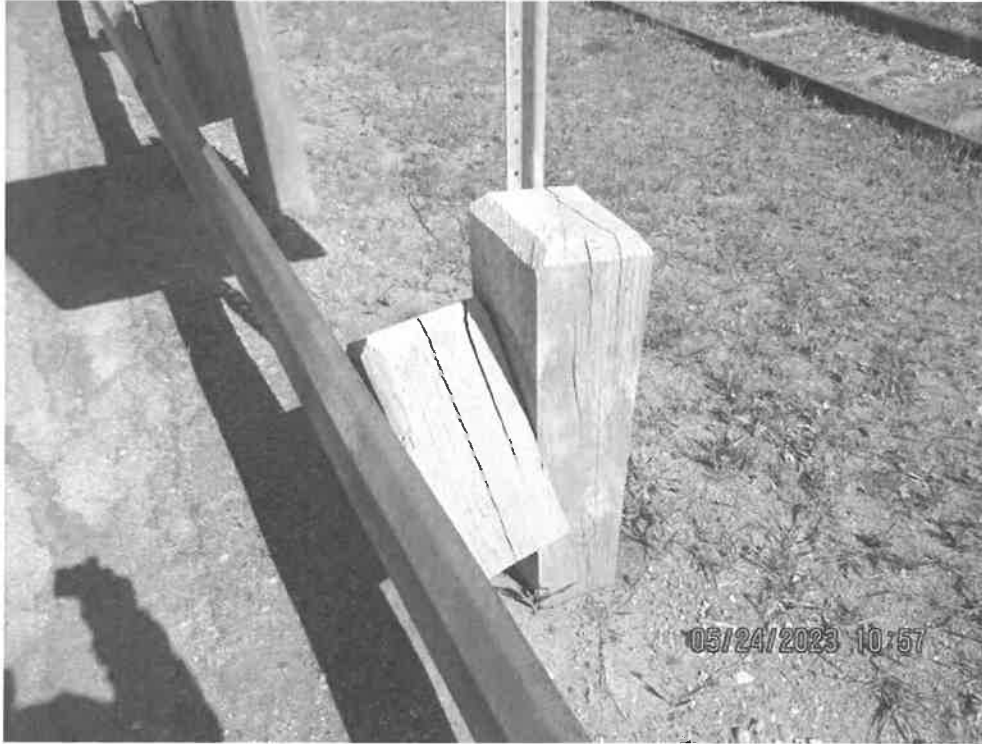
Photo 19: Rotated loose offset timber at guide rail post (typ.).

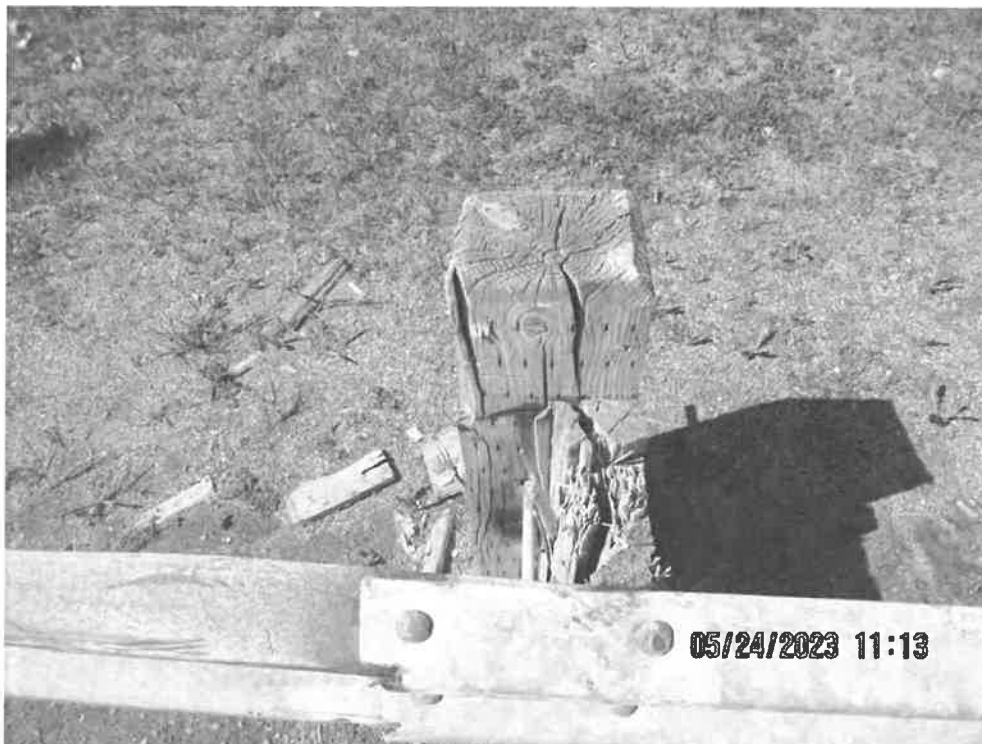
Photo 20: Severe rot at offset at northeast approach.

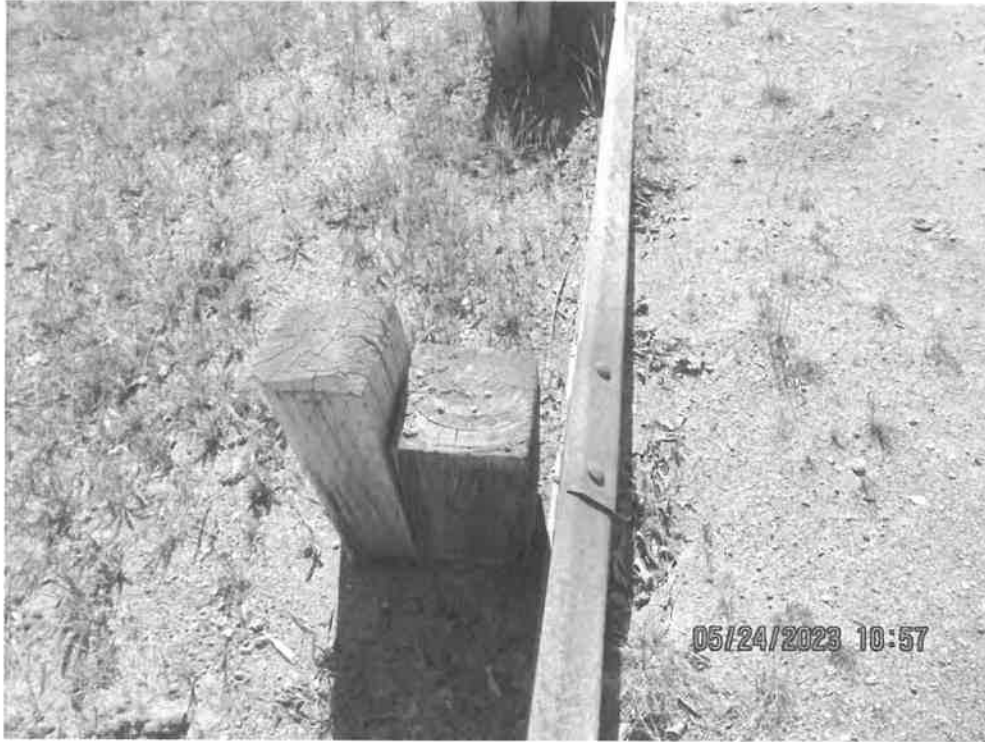
Photo 21: Missing bolt at guide rail to post connection.

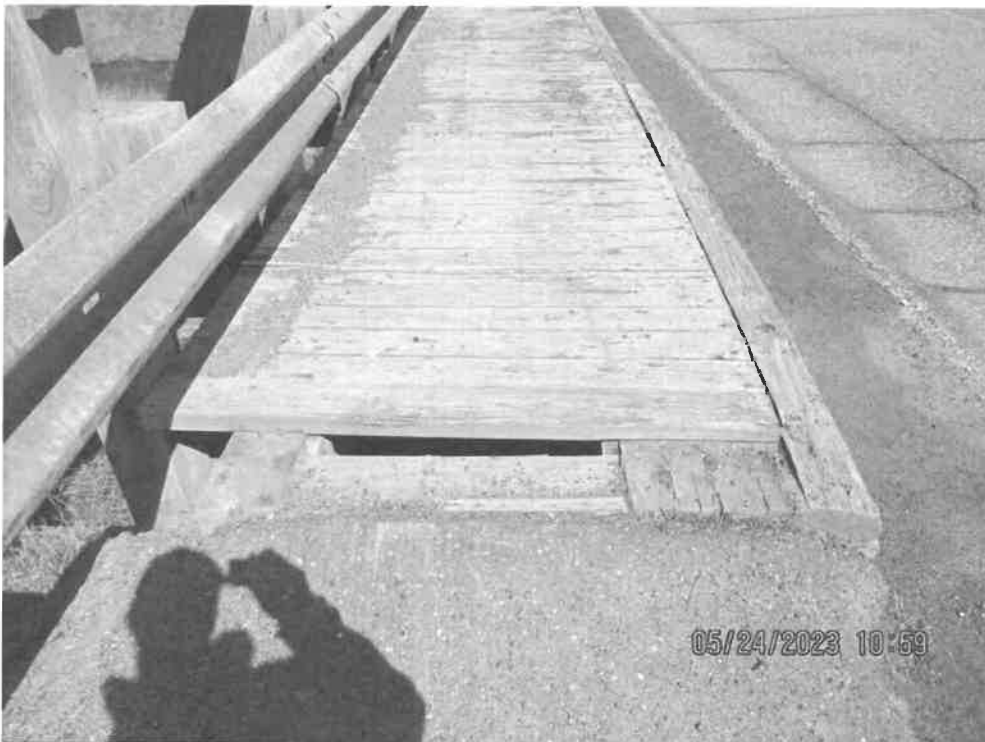
Photo 22: Three missing deck timbers at walkway.

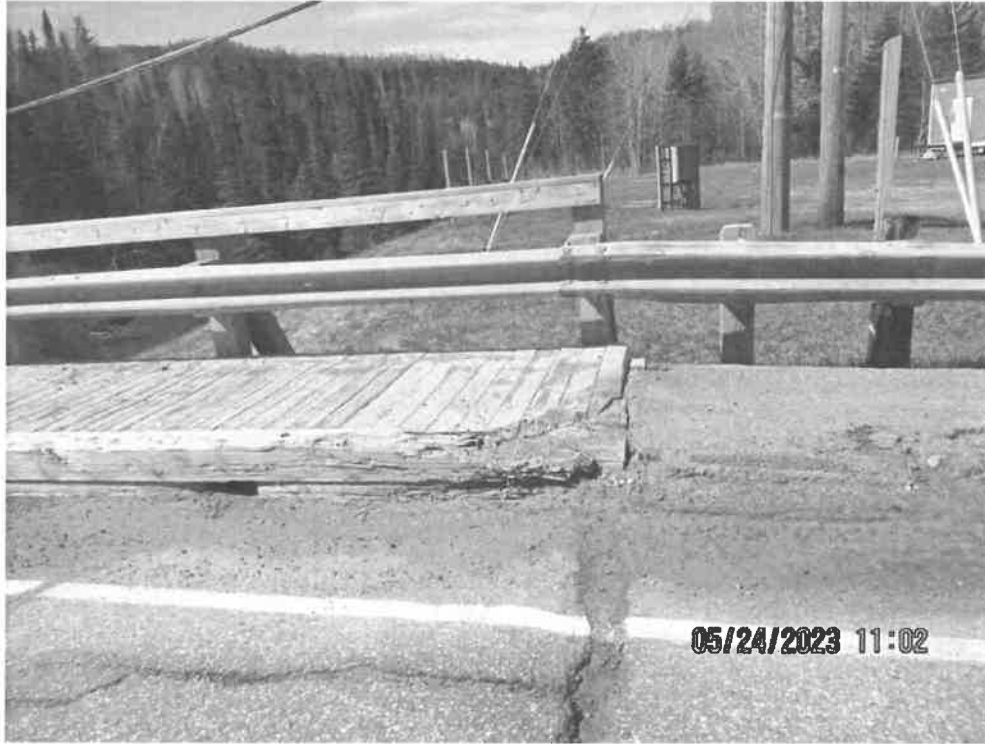
Photo 23: Impact damage at curb at north end.

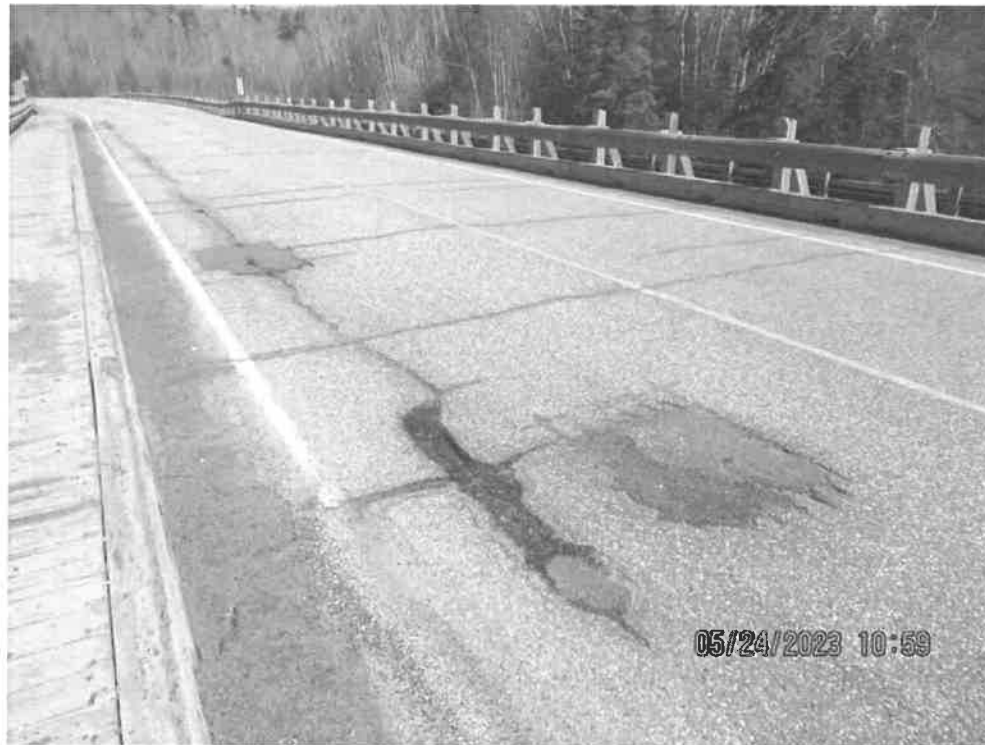
Photo 24: Severe longitudinal crack full length of deck at southbound lane.

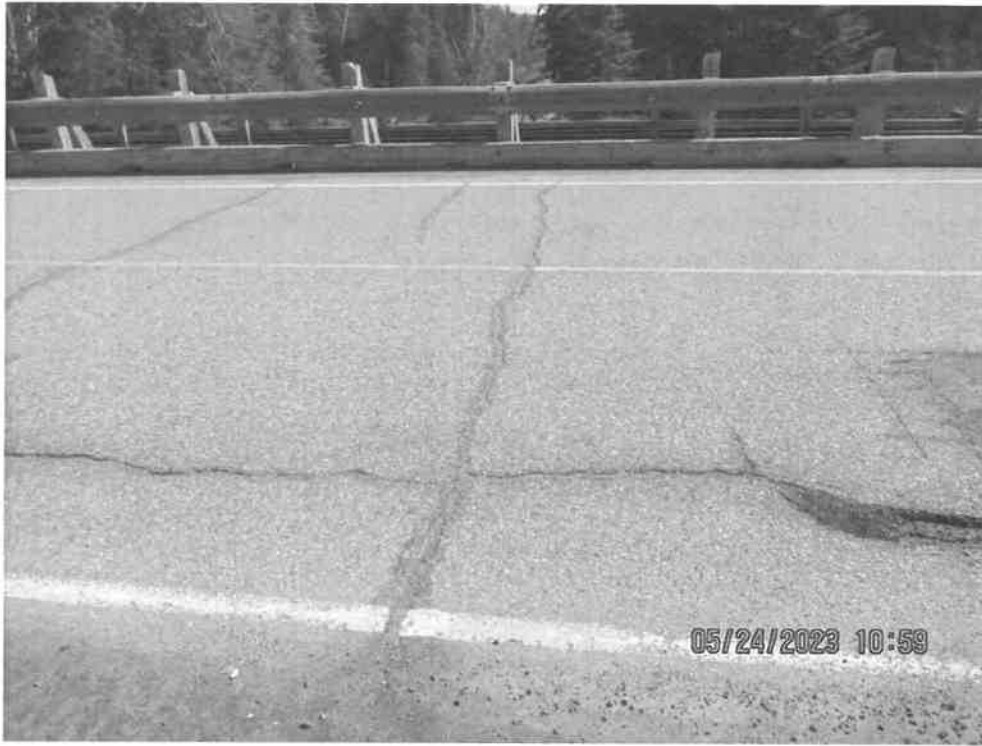
Photo 25: Severe transverse cracks full width of deck.

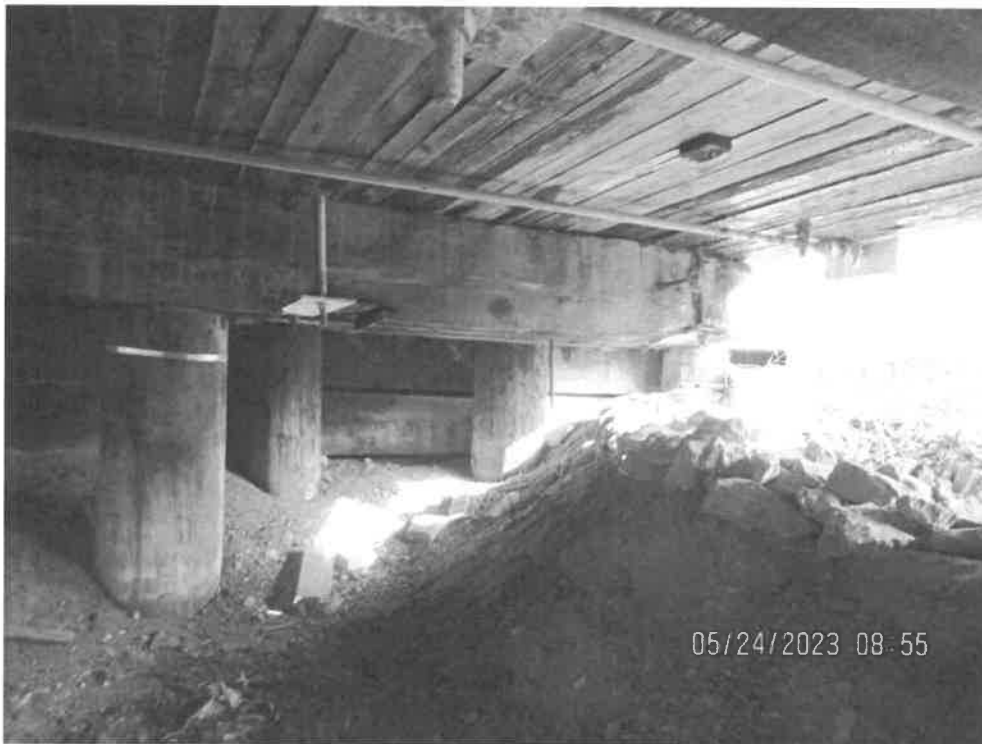
Photo 26: First pile from east removed at Bent #14.

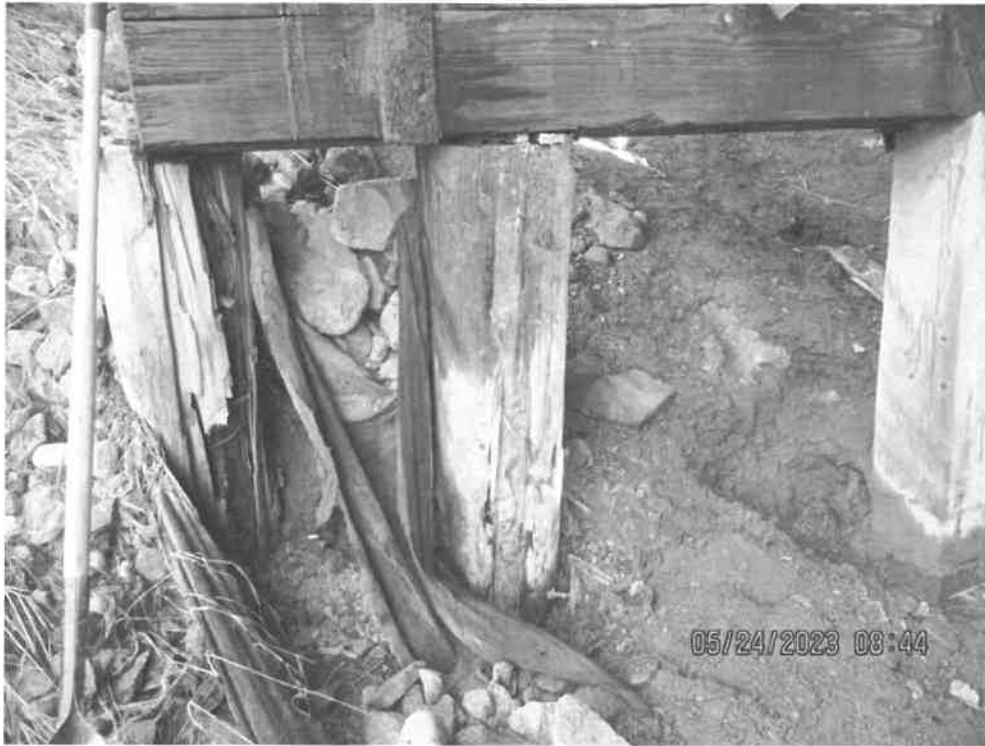
At Red Rock Bridge No. 1, Bent #12 has rotated toward the watercourse, resulting in a significant lean at the columns and piles. Bent #12 also contains numerous very severely rotten and split piles, and the pile cap does not bear adequately upon the piles. Elsewhere, severely rotten pile caps and piles were observed. These deficiencies are detrimental to the load carrying capacity of the structure, and require rehabilitation to be completed in the next 3-4 months. The estimated construction cost for this work, including engineering and contingency, is approximately \$ 260,000.00 + HST.

Photo 27: Very severe rot at 8th pile from east at Bent #12.

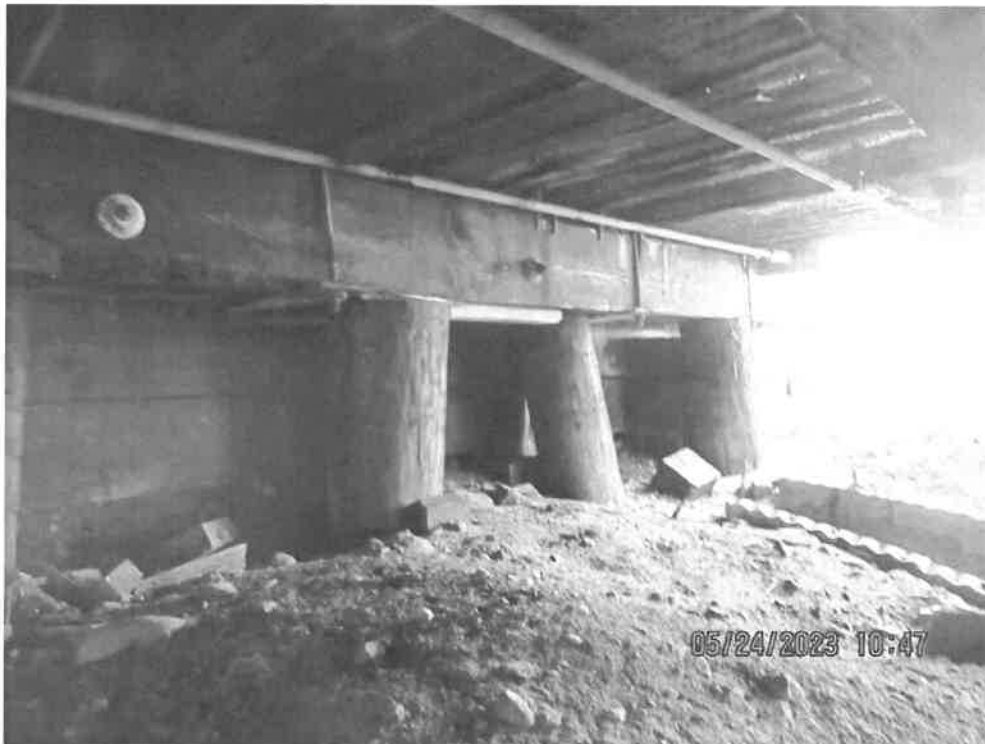
Photo 28: Approximately 50% contact at two piles at the south abutment (9th and 10th pile from east).

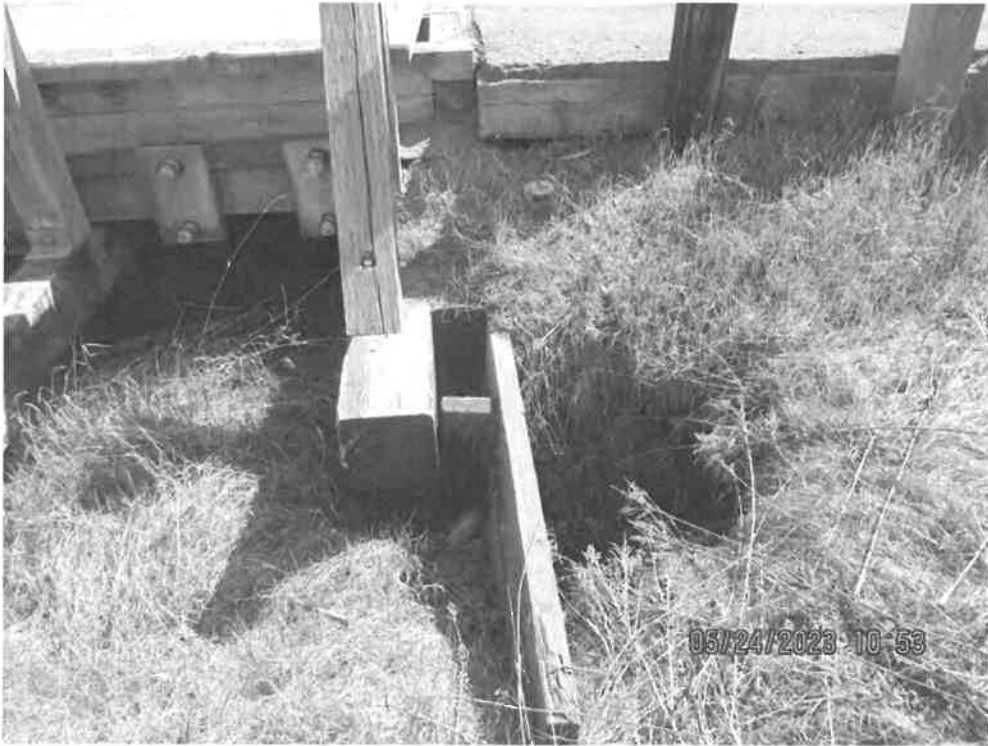
Photo 31: Erosion at southwest embankment.

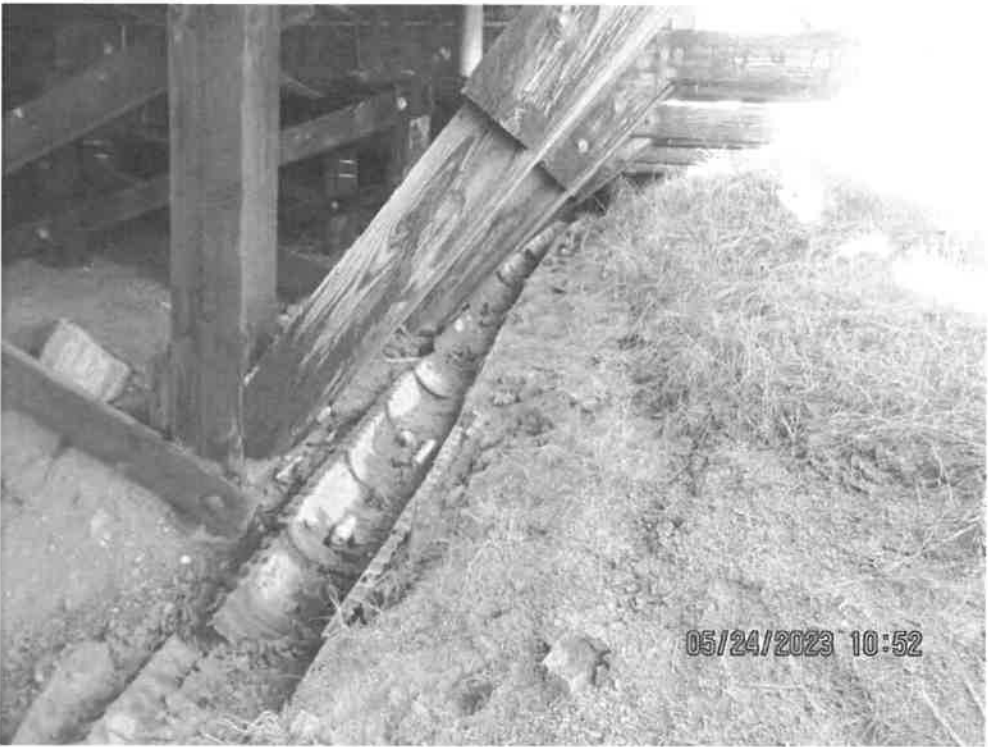
U-shaped CSP culverts that were installed to reduce erosion at the embankments have severely corroded. Severe erosion was observed at the south embankment beneath the bridge and at the northwest embankment.

Photo 32: Severe corrosion at drainage culvert at southwest corner.

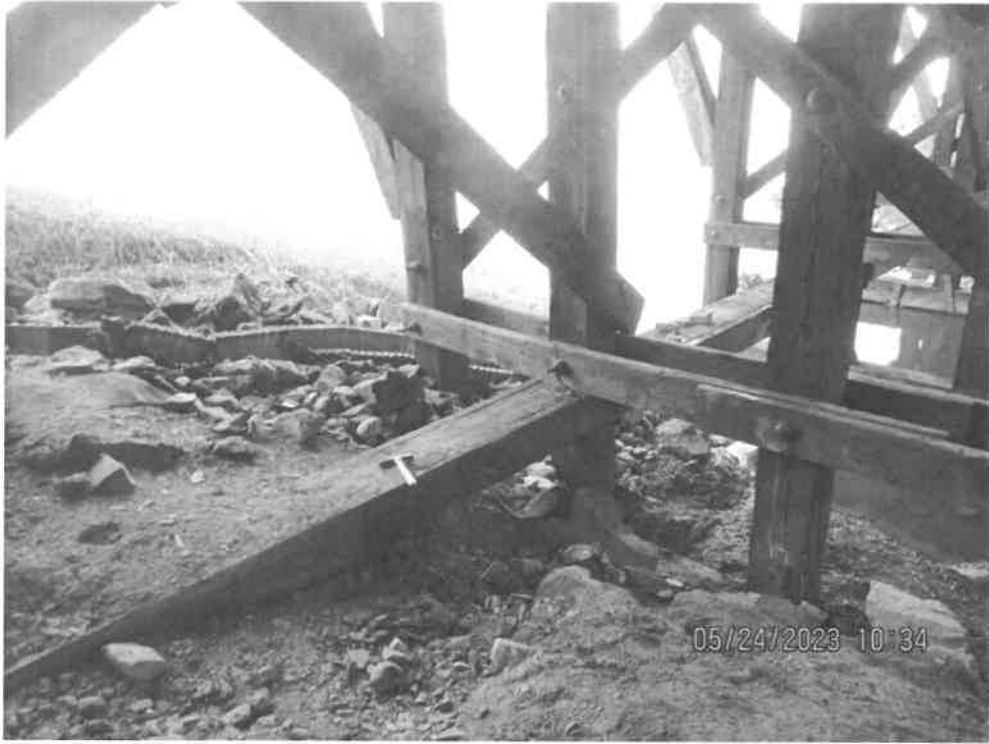
Photo 33: Severe erosion at south embankment.

- Excavate the north and south embankments to remove excess soil. Reshape the embankments to flatten the slopes. This should reduce subsurface slippage at the embankments, and reduce movements at the bents. The U-shaped culverts will be removed and replaced in kind or with asphalt swales to facilitate this work.

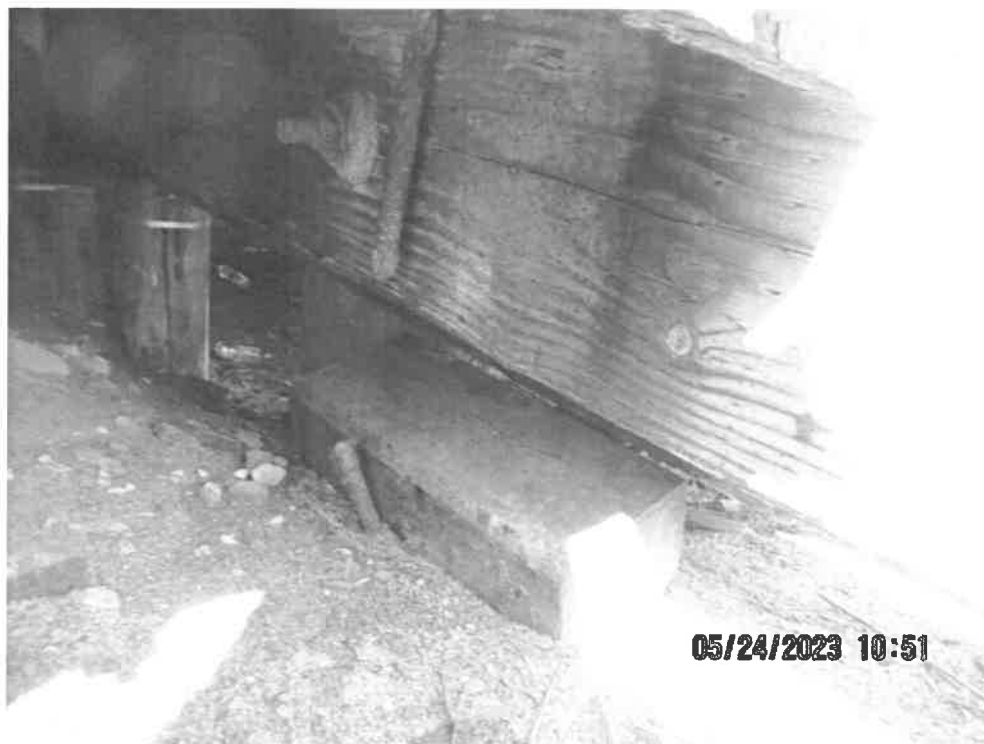
One broken clamp was observed at the guide rail outrigger at Bent #2.

Photo 36: Broken thru-bolt at clamp at Bent #2.

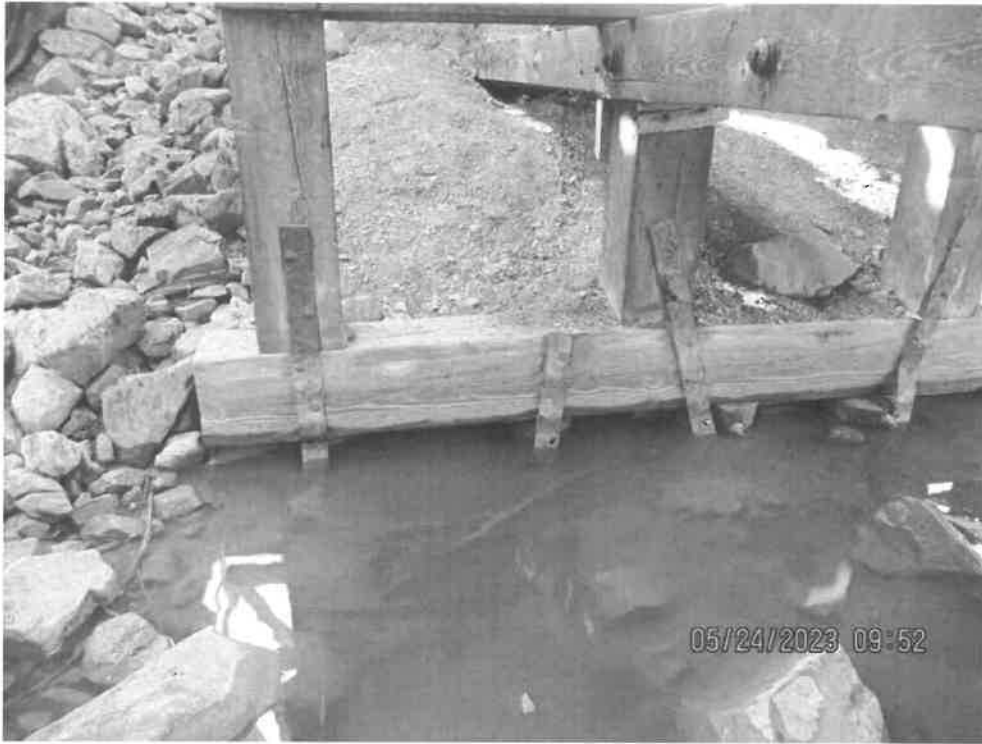
Photo 37: Strapping buckled at pile (typ.).

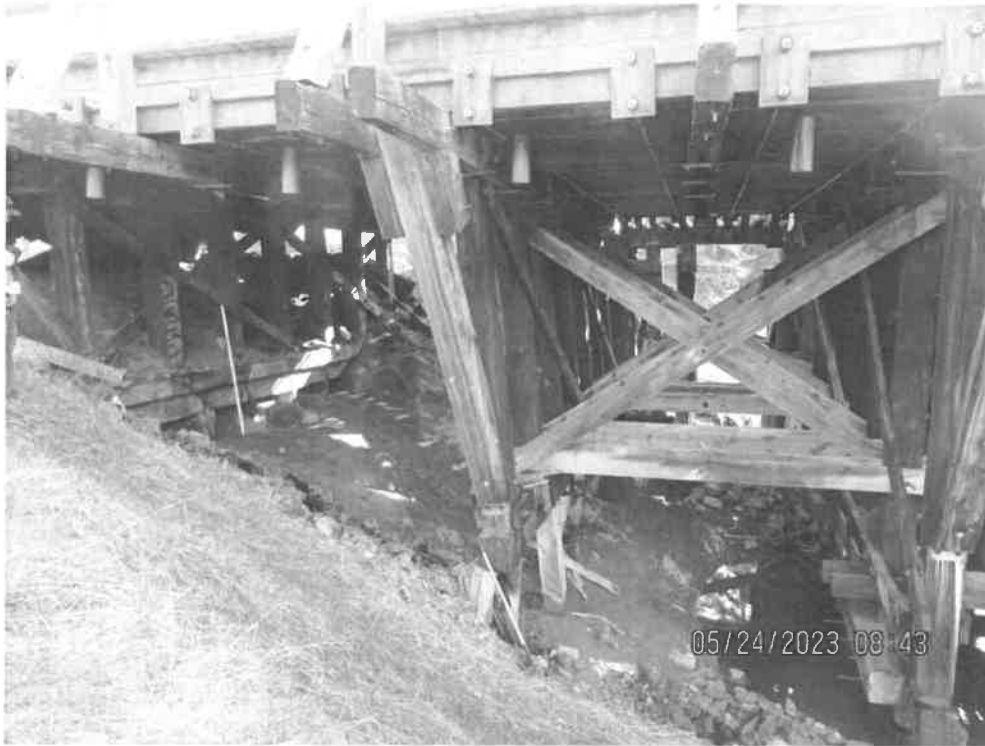
Photo 39: Rotation of piles and pile cap at Bent #12.

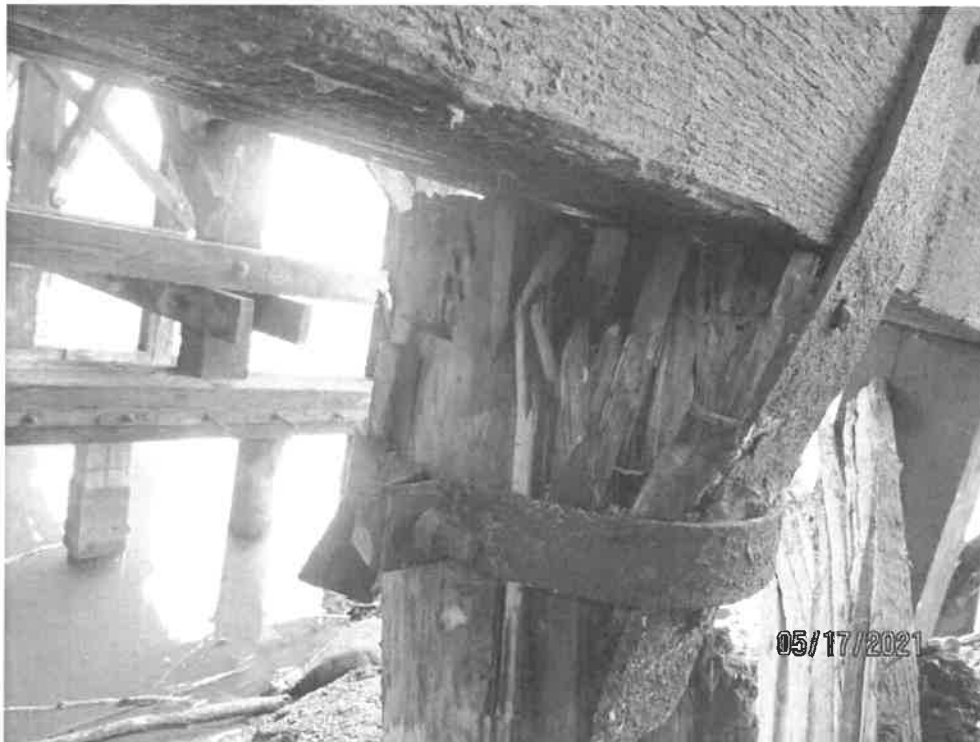
Photo 40: Severe rot and pile not in contact at Bent #12.

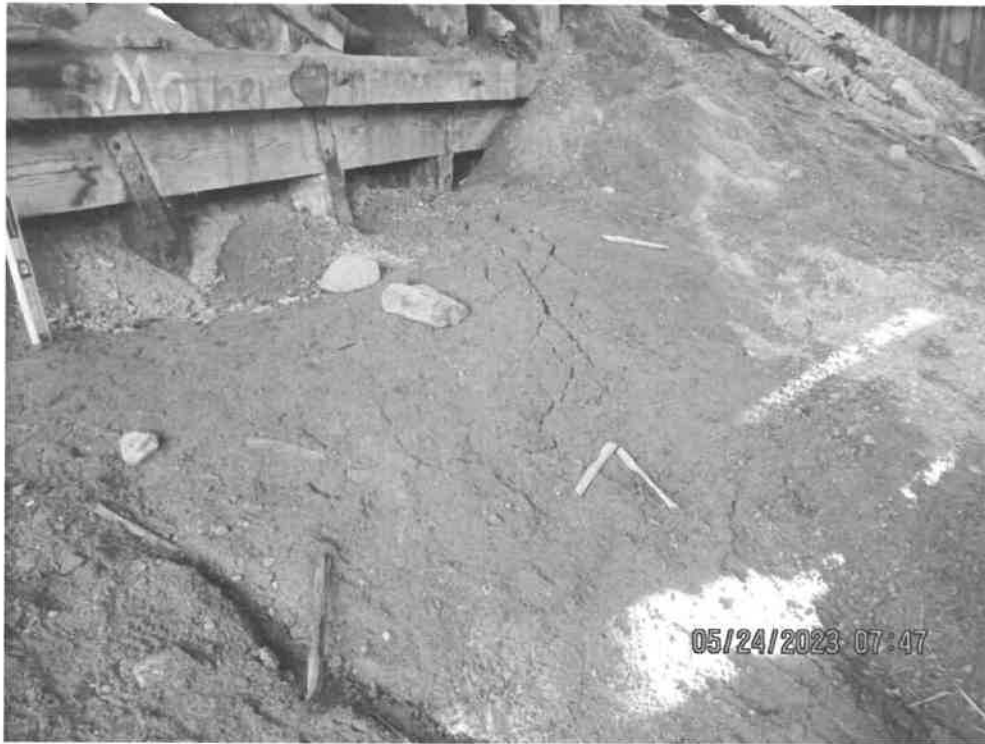
Photo 43: Cracks in soil between Bent #12 and #13.

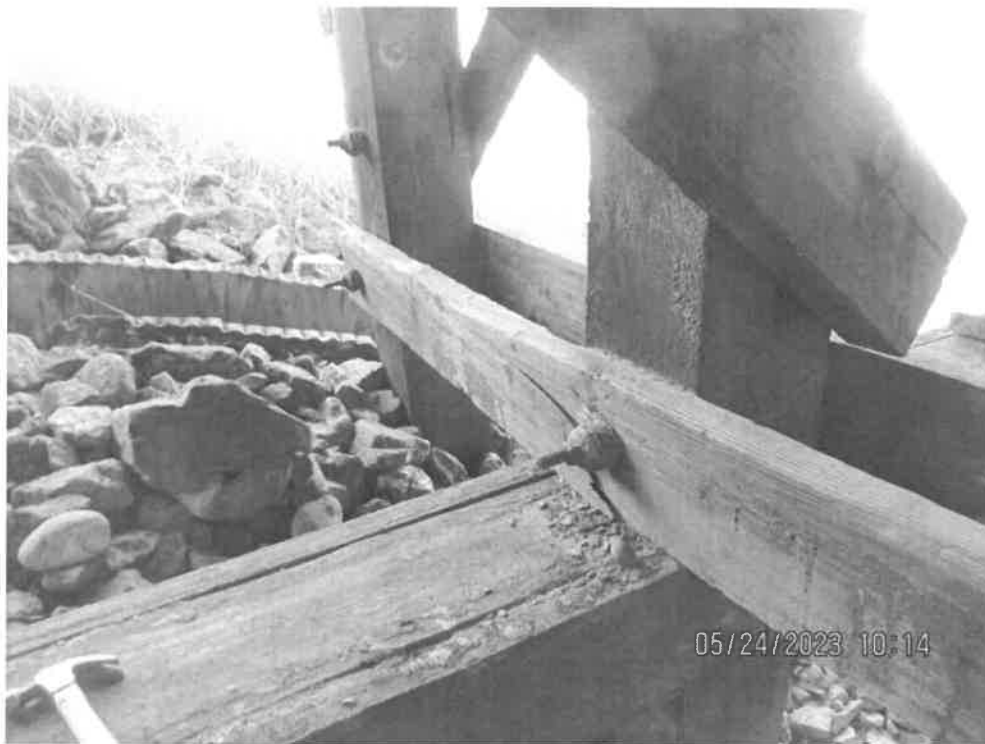
Broken timber braces were observed at Bent #5 and severe rot was observed at a brace at Bent #4.

Photo 44: Broken timber brace (typ.).

- Cut and splice the top of the rotten piles at Bents #11 and #13.
- Replace broken timber braces at Bent #5.

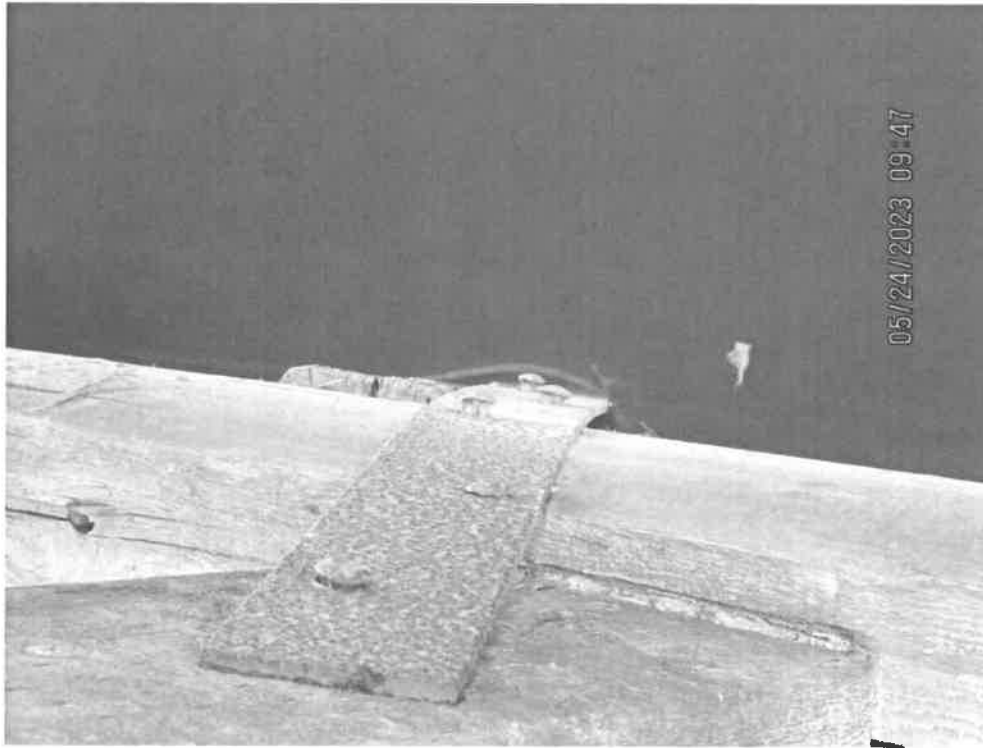
Very severe rot was observed at the east end of the pile caps at Bent #5 and Bent #6.

Photo 45: Very severe rot at pile cap.

- Reset the column at Bent #11 plumb.
- Replace the two rotten sections of pile caps at Bent #5 and Bent #6. This will also require temporary closure and temporary shoring of the bridge.

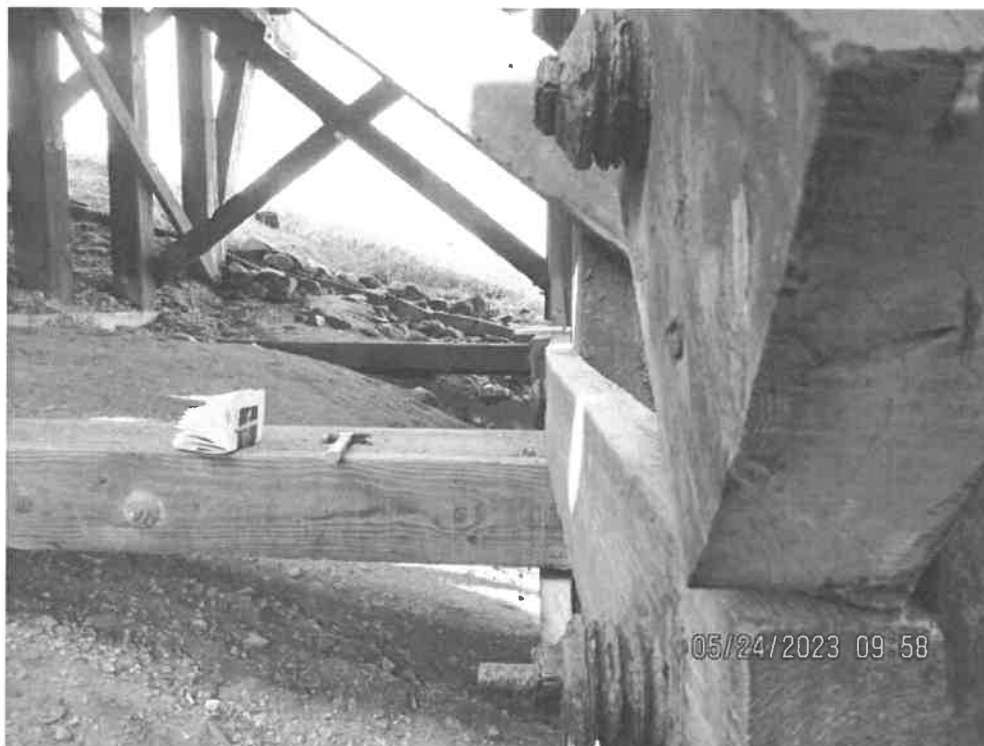
Photo 46: Typical translation of piles and bents.

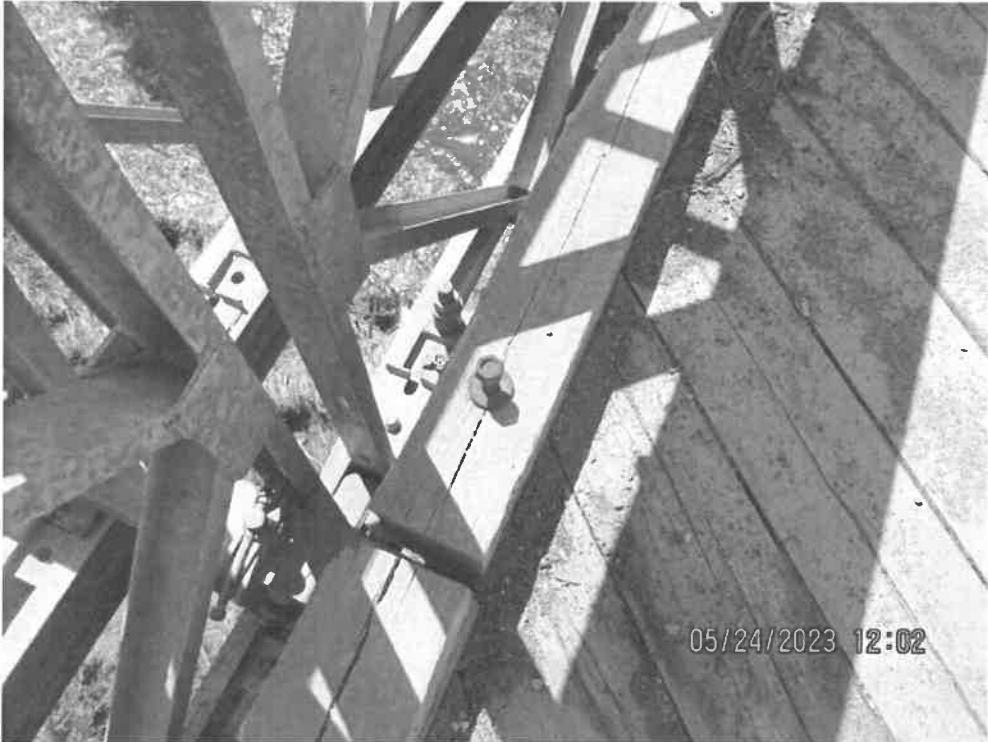
Photo 15: Loose/missing bolt at curb (typ.).

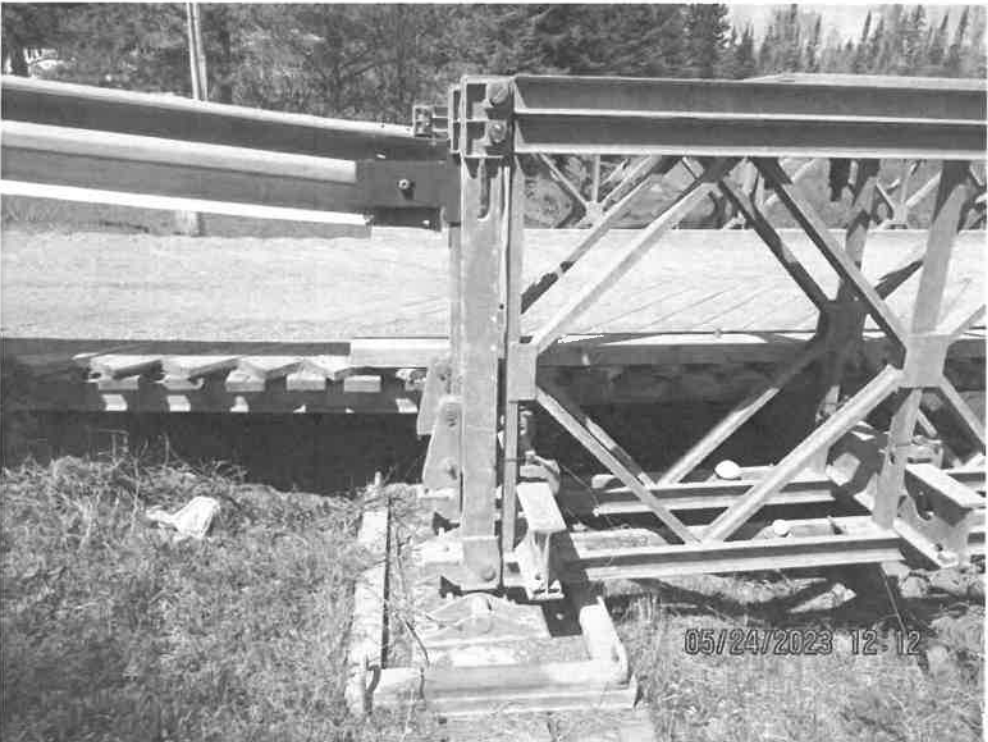
Photo 16: Improper connection of guide rail to bridge.

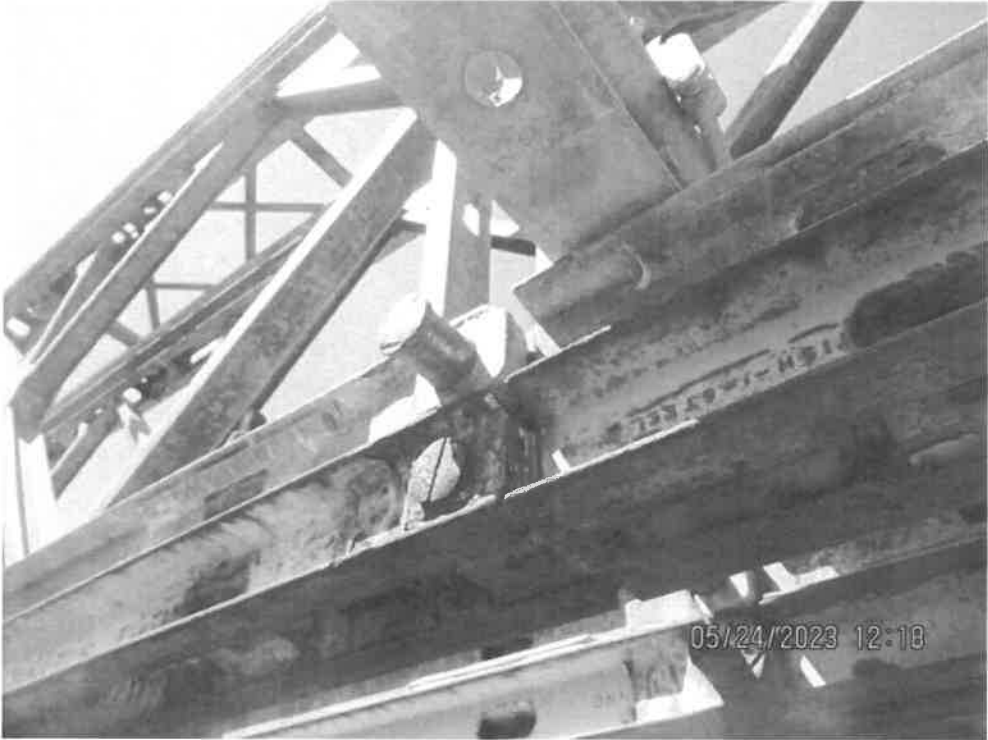
At Red Rock Bridge No. 3, several cotter pins which prevent the truss panel connection pins from loosening and falling out are missing. One panel pin has shifted 75 mm. We recommend new cotter pins be provided and the shifted panel pin be driven back into position. This work is urgent and should be completed in the next 1-3 months.

Photo 17: Loose panel pin.

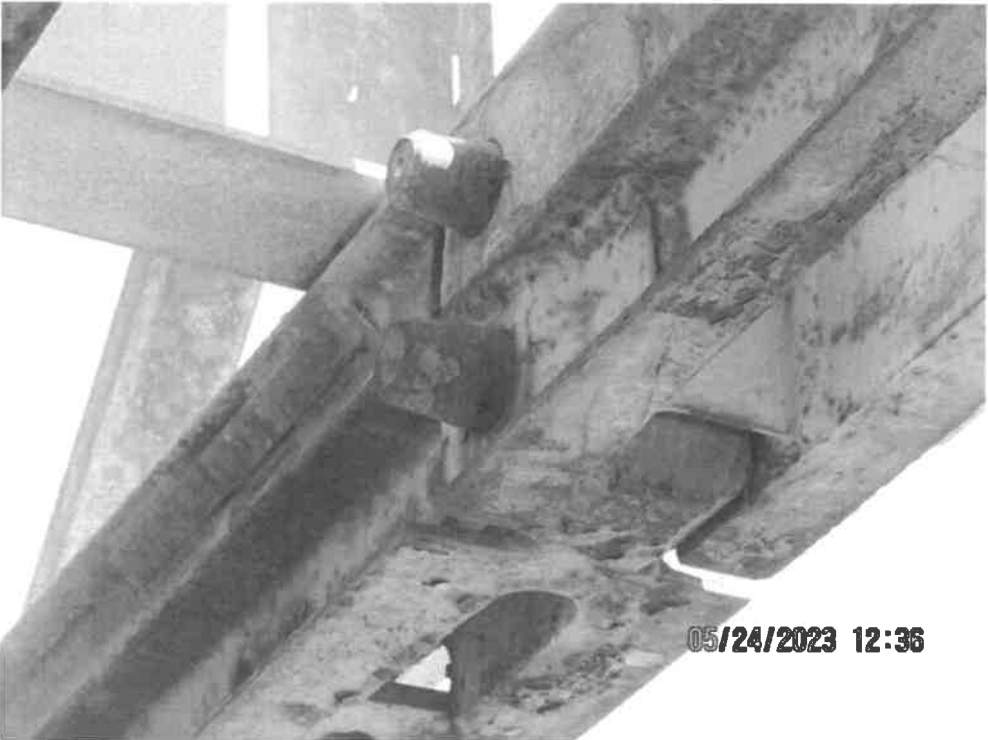
Photo 18: Loose cotter pin/panel pin.

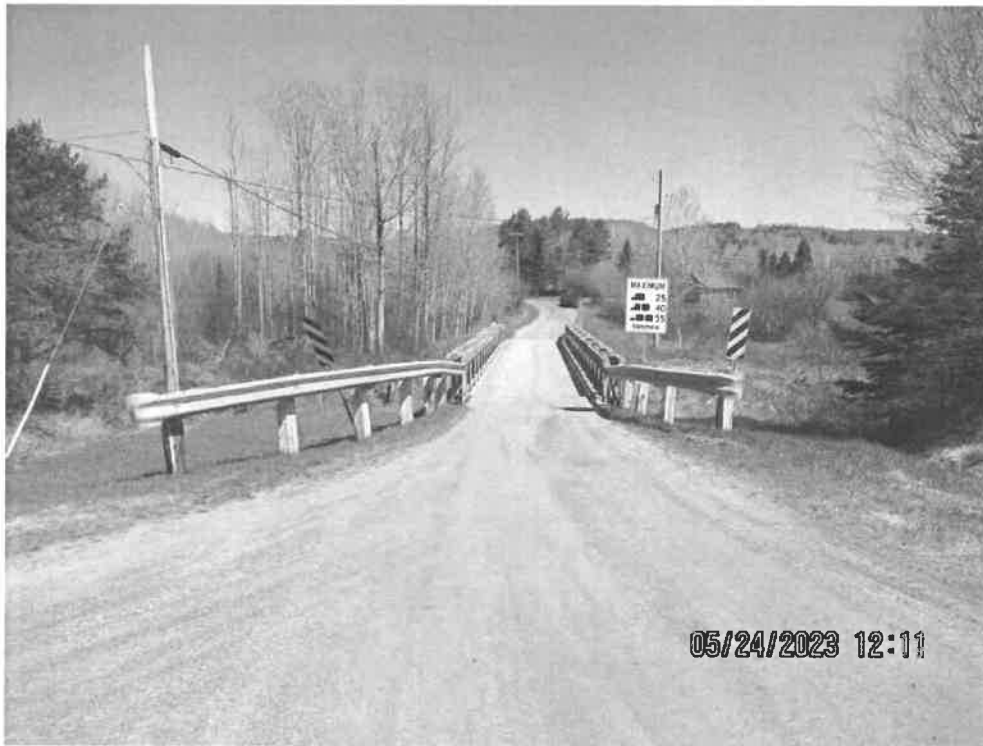
Photo 19: Guide rail mounted at improper height at southwest corner. Southwest Hazard Marker sign is leaning.
