Bi-annual Inspection Four Bridges One Culvert

**FOR THE
TOWNSHIP OF RED ROCK**

Ref. No. JML2023013

Reference: **Bi-Annual Inspection Four Bridges One Culvert**

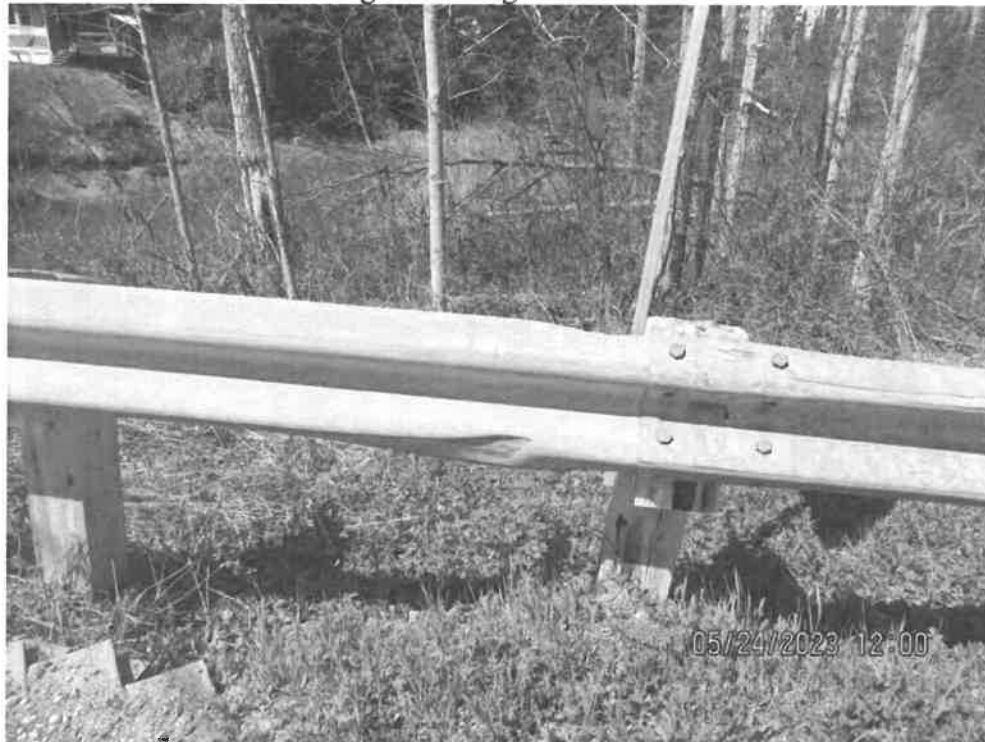
Photo 20: Guide rail splice bolts missing at all locations.

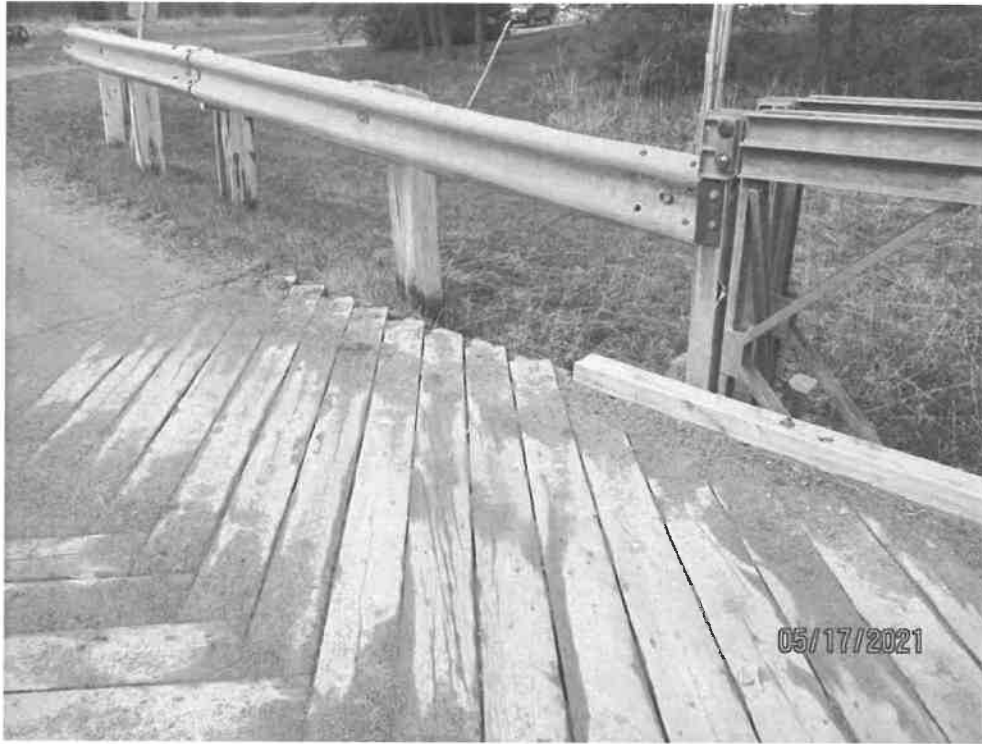
Photo 21: Impact damage at guide rail. Missing curb at 4 corners of approaches.

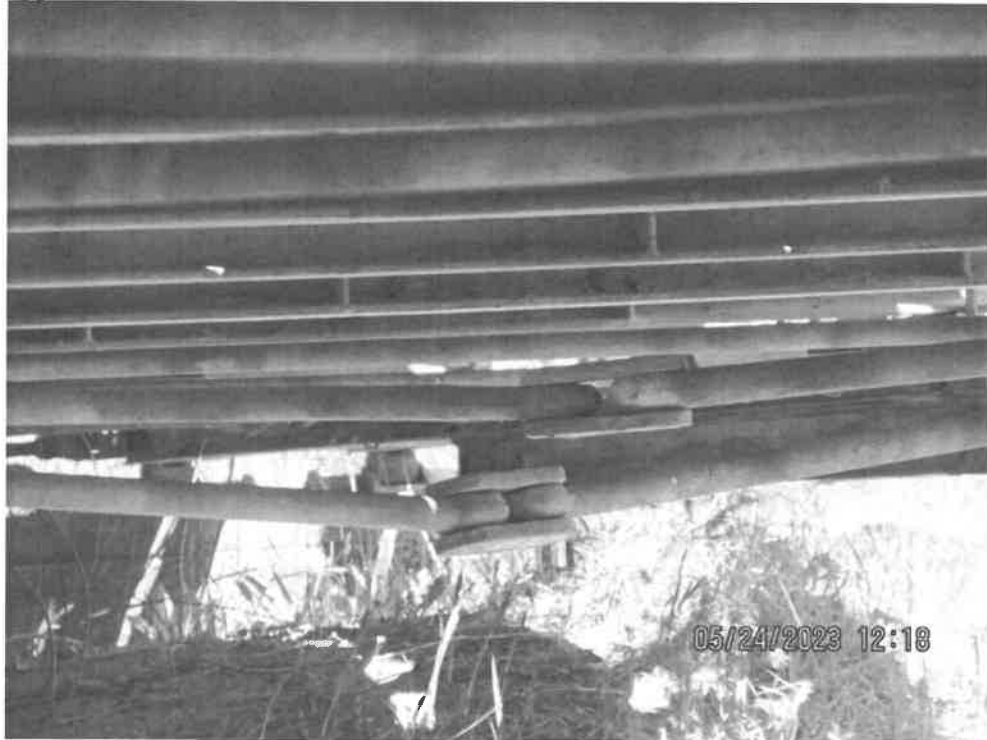
Photo 22: Loose sway bracing beneath bridge.

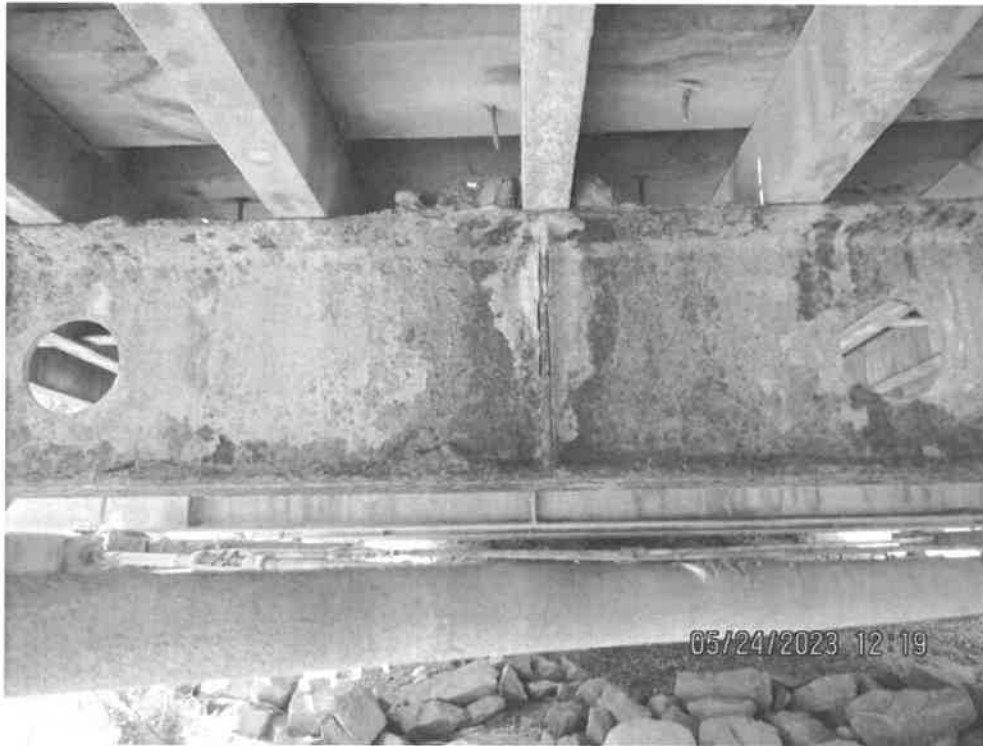
Photo 23: Medium corrosion at transom.

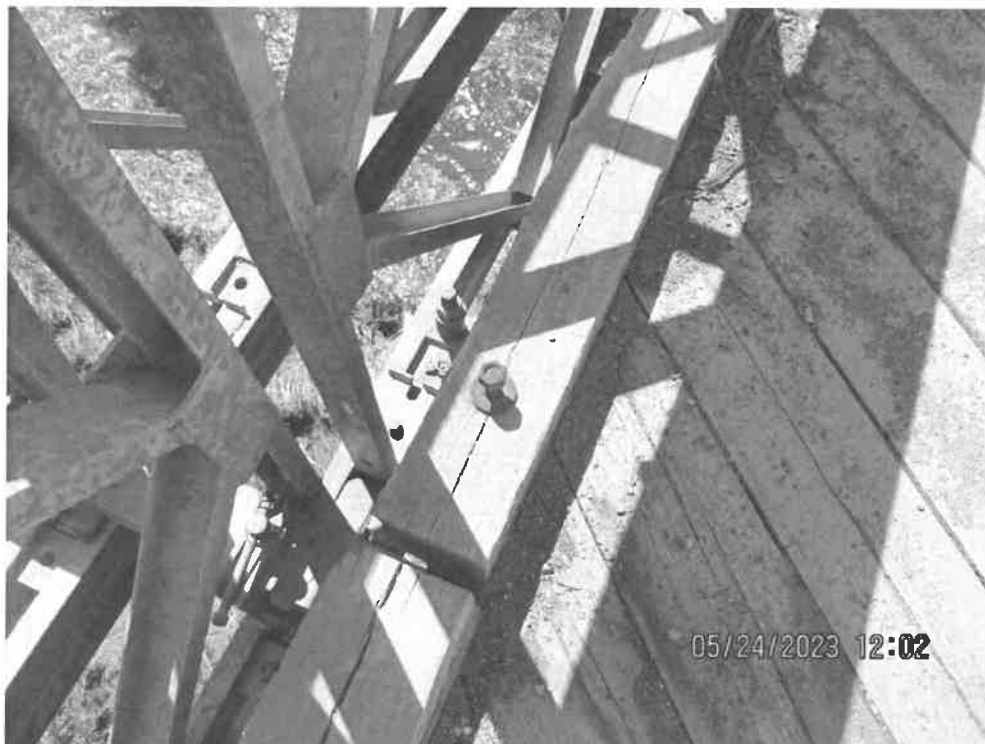
Photo 24: Loose curb bolts (typ.).

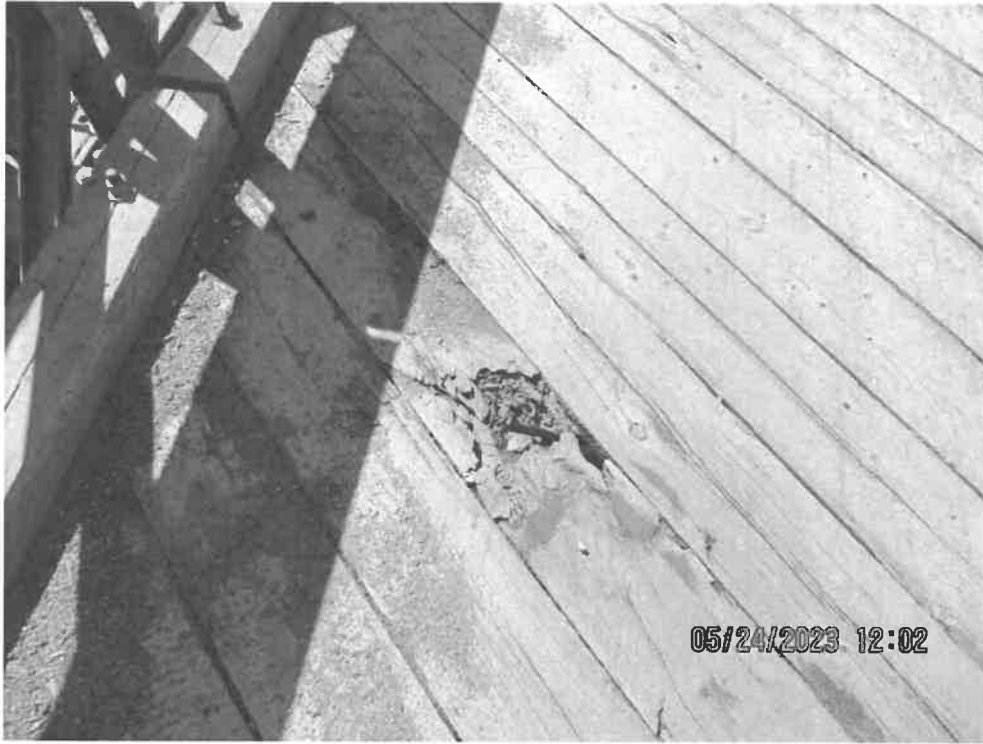
Photo 25: Severe rot at wearing surface.

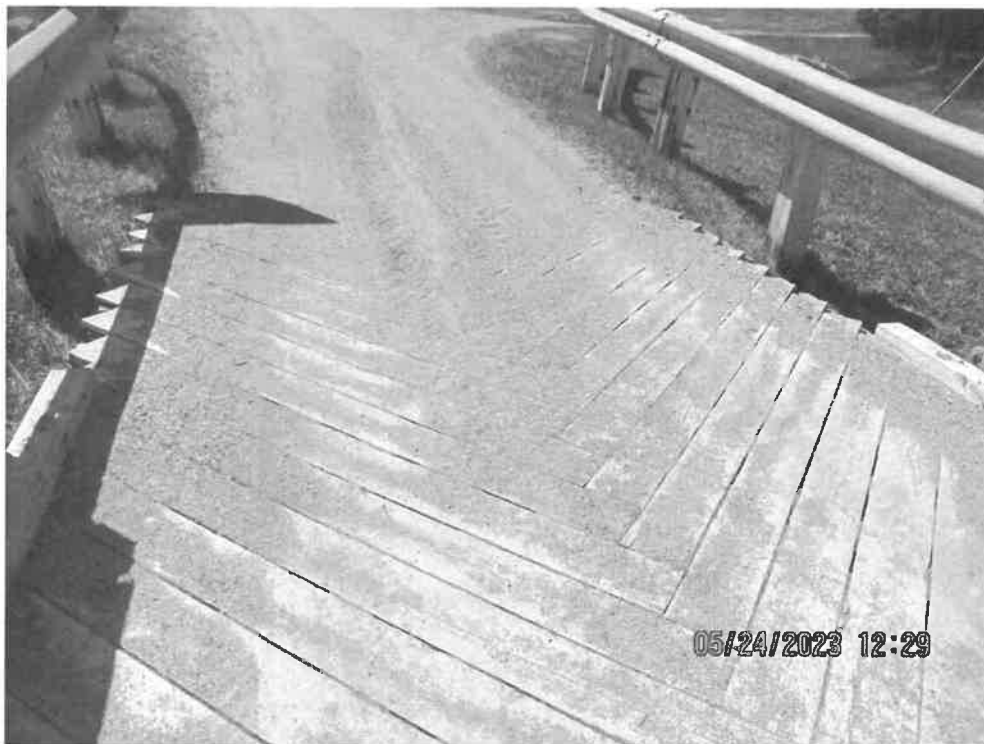
Photo 26: Gravel accumulation at approach ramp.

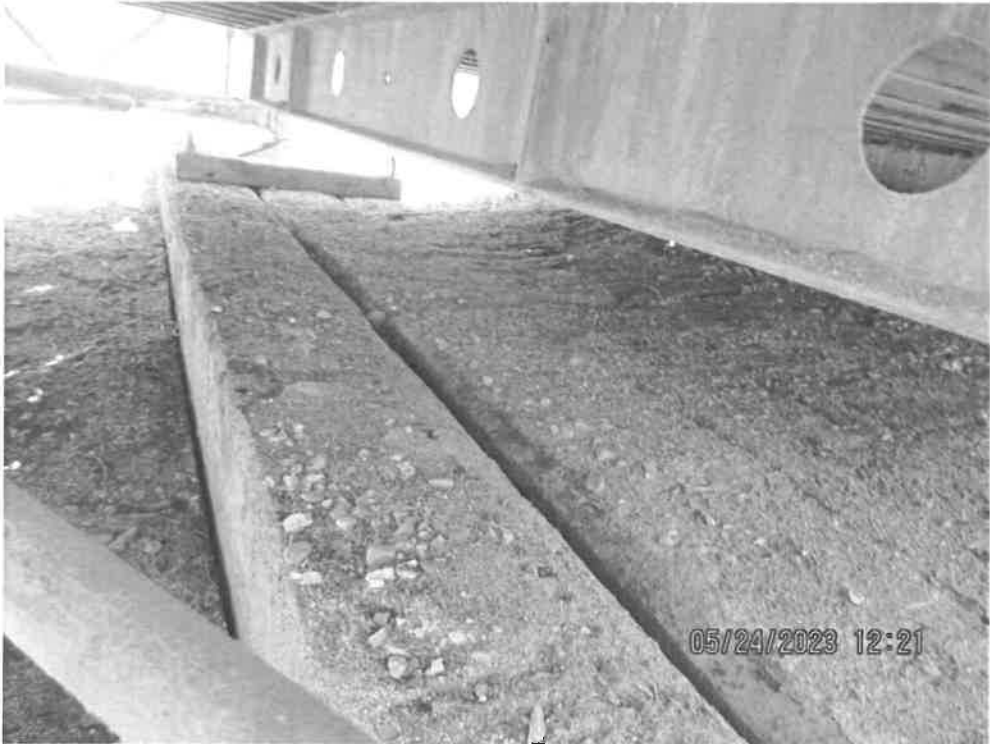
Photo 27: Gravel accumulation at bearing timber (typ.).

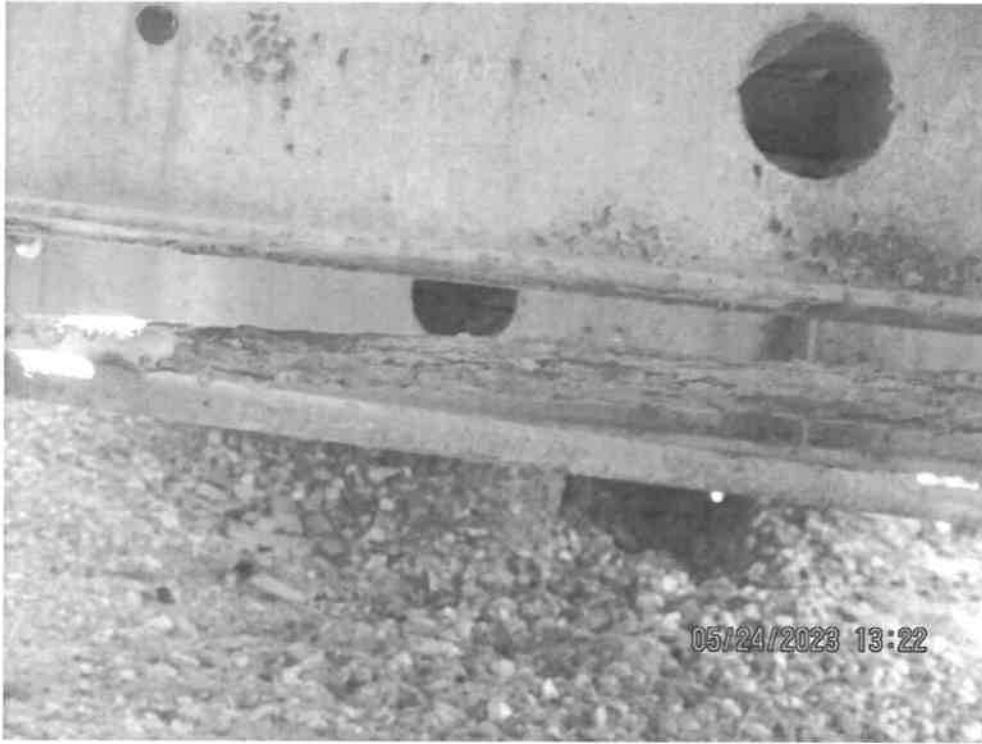
Photo 15: Severe corrosion at diagonal bracing at south end.

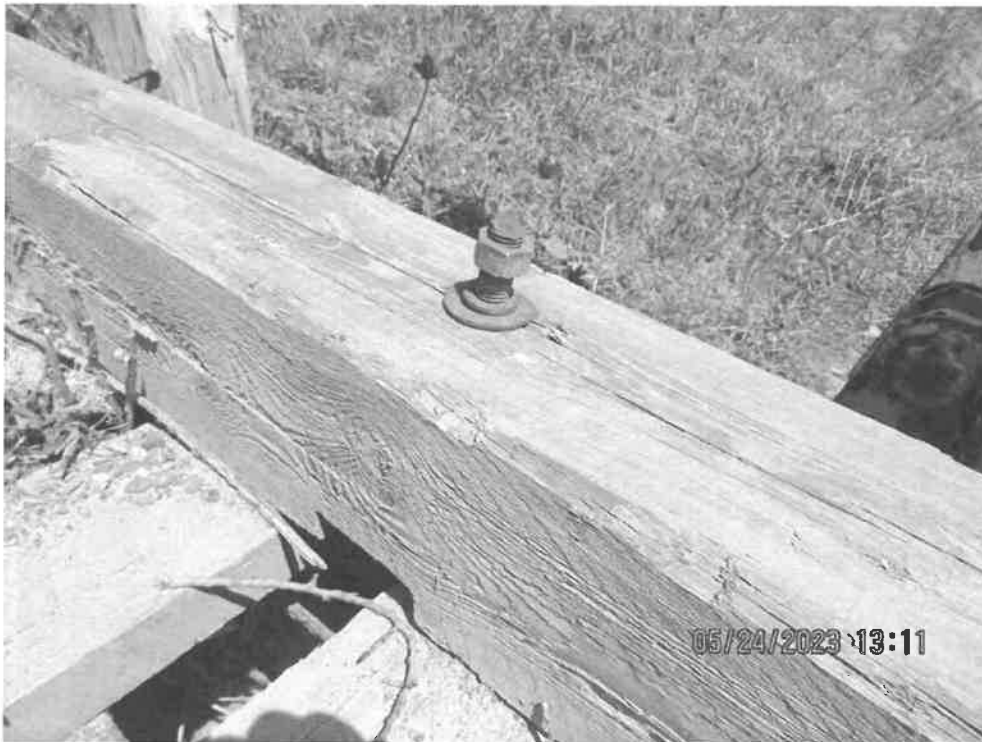
Photo 16: Loose bolt at curb (typ.).

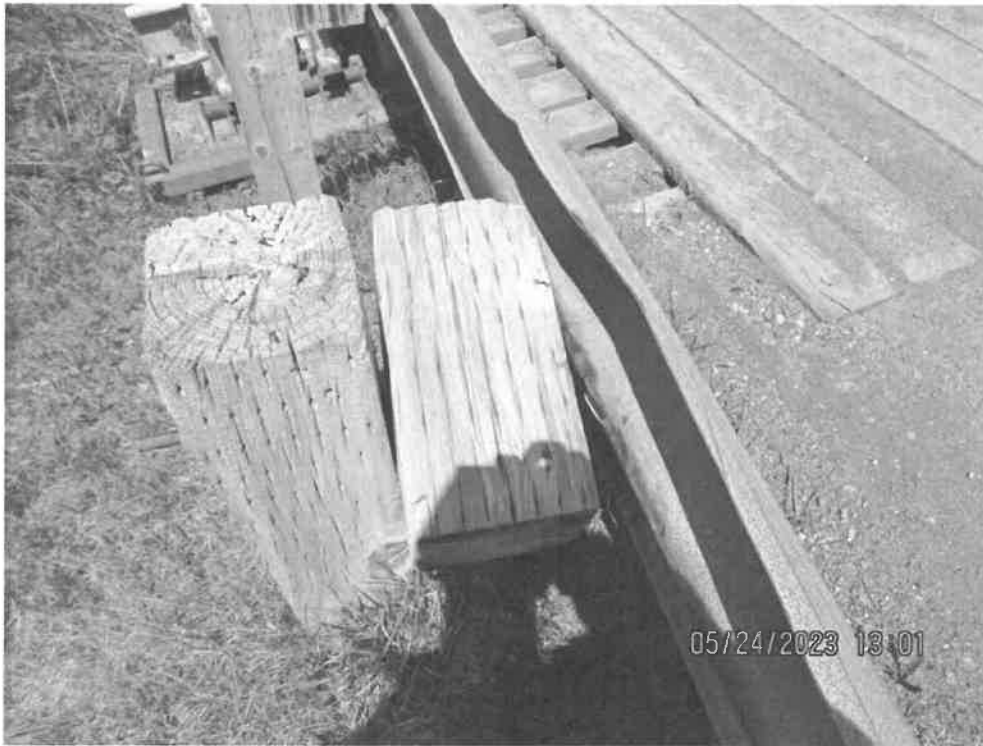
Photo 17: Rotated offset (typ.).

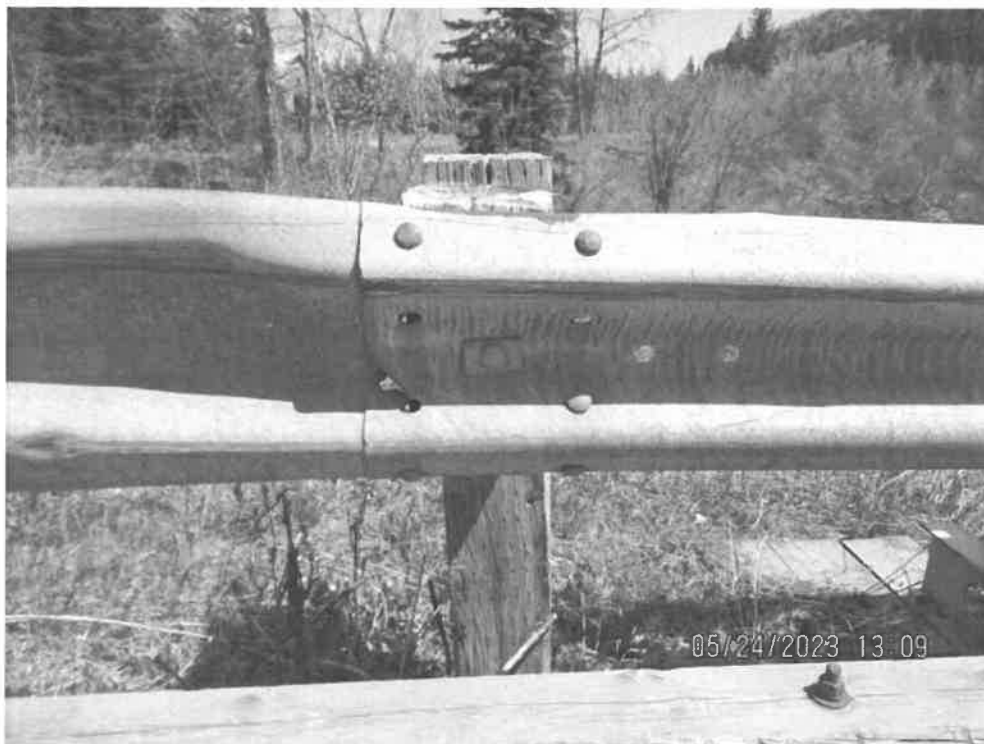
Photo 18: Missing bolts at guide rail splice (typ.).

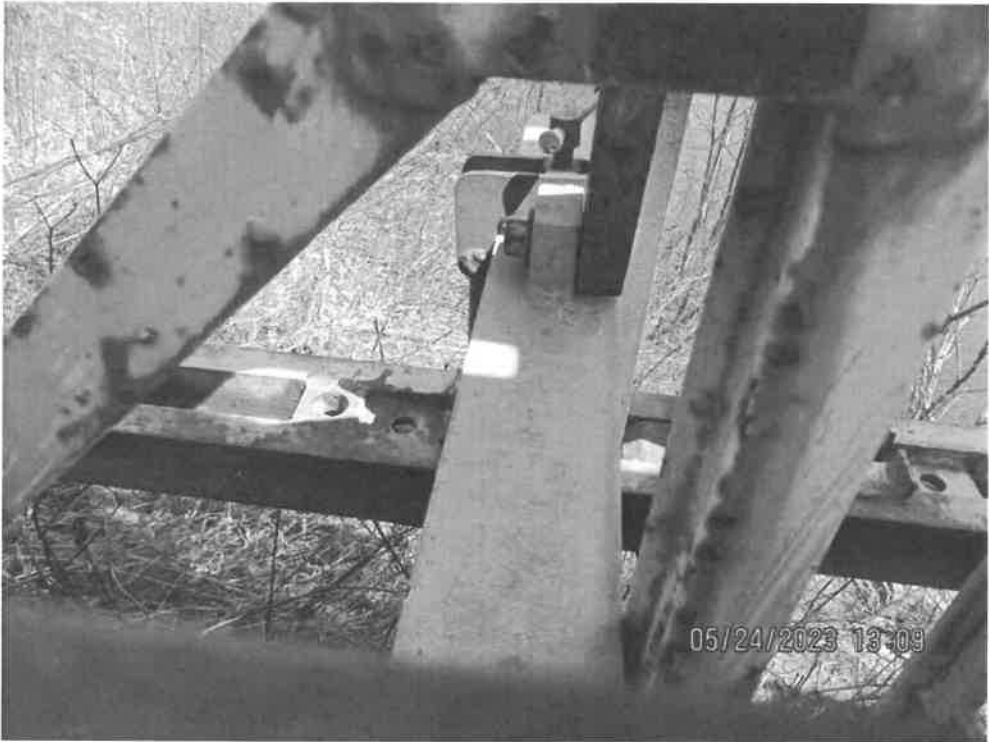
Photo 19: Missing transom clamp at east side.

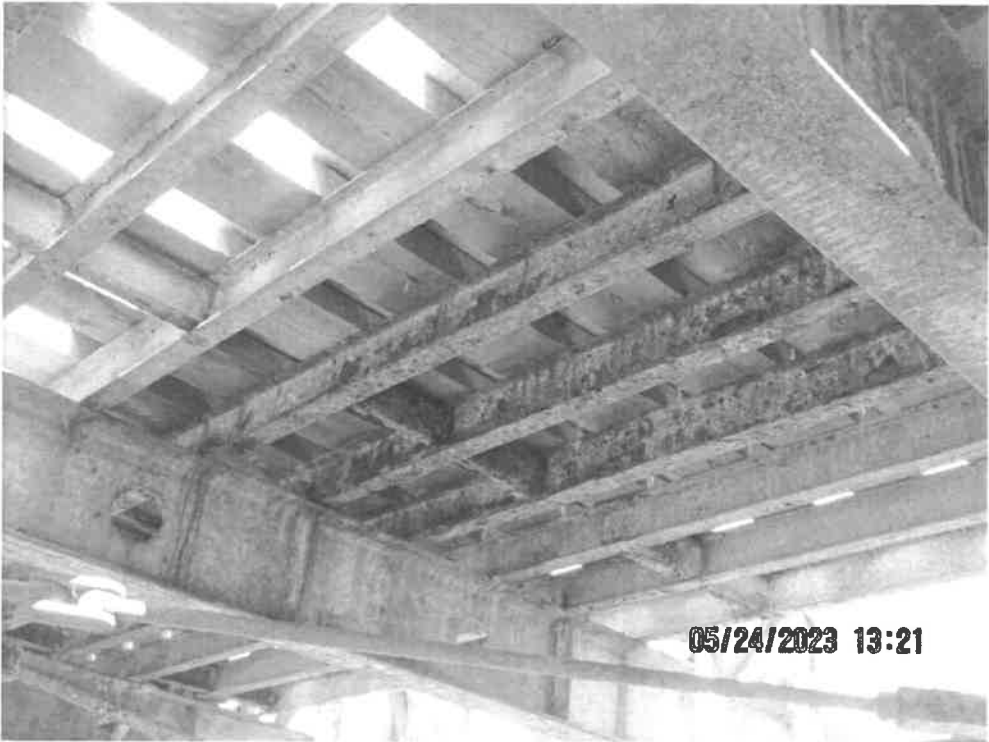
Photo 20: Severely corroded stringers (typ.).

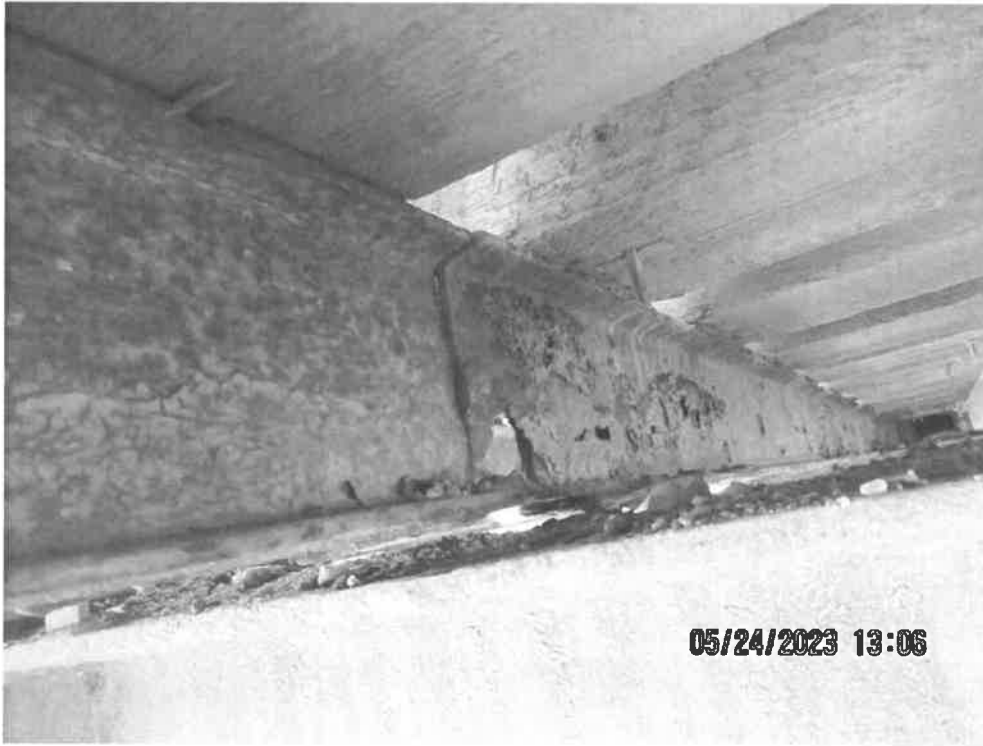
Photo 21: Stringer set not bearing on transom.

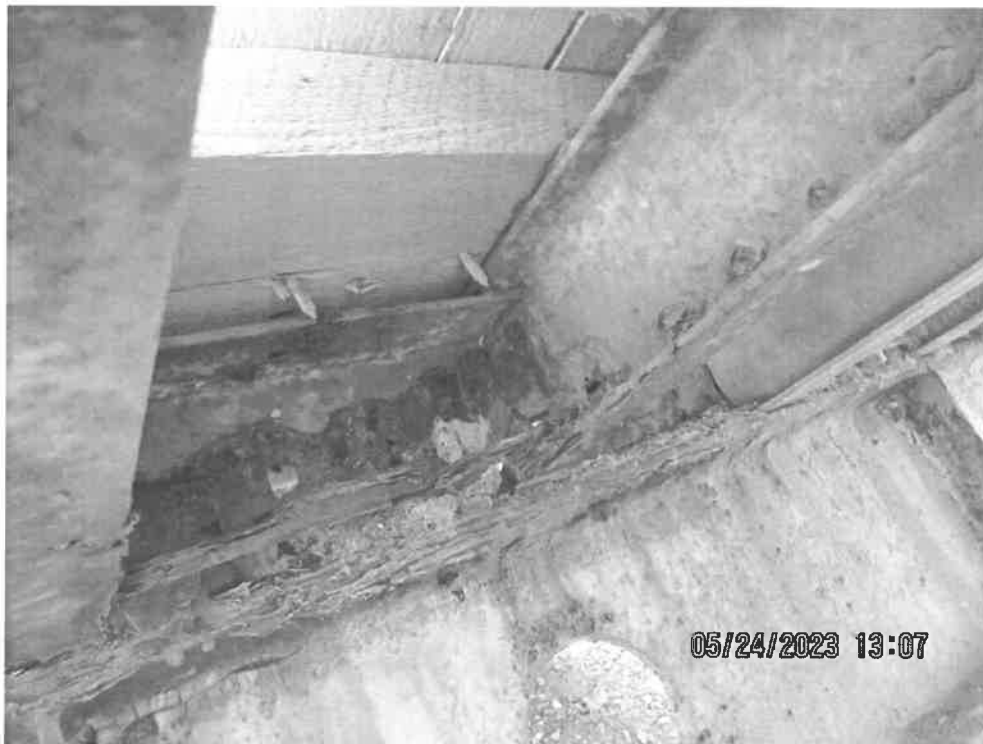
Photo 22: Severe corrosion at end diaphragm of stringer set.

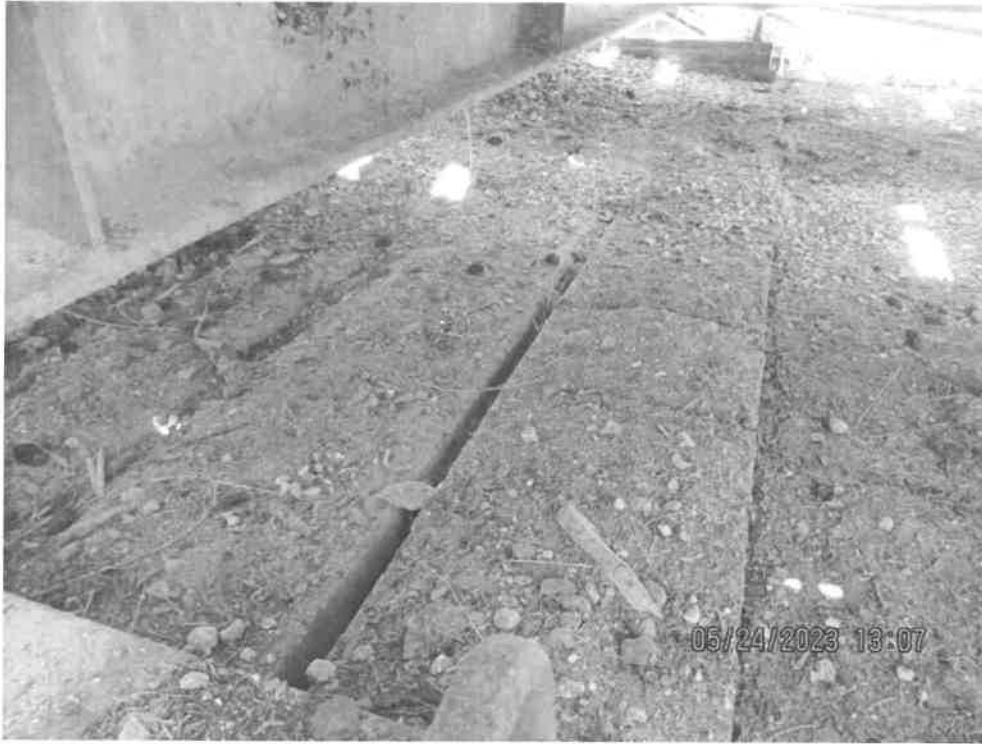
Photo 23: Gravel accumulation at abutment (typ.).

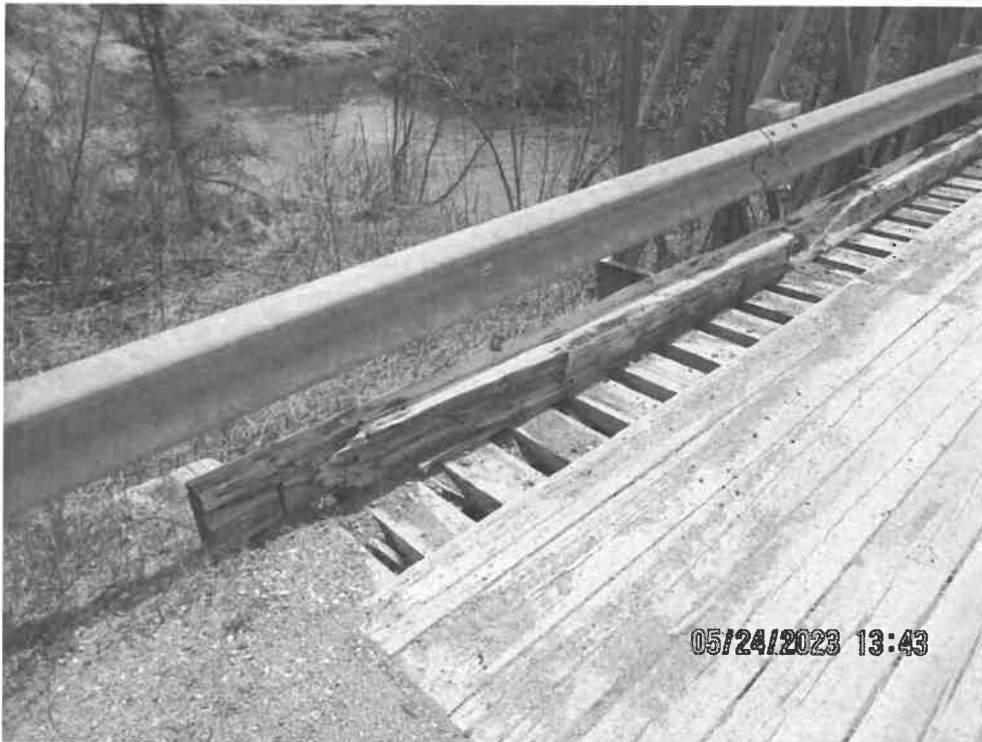
Photo 24: Severe impact damage at curb.

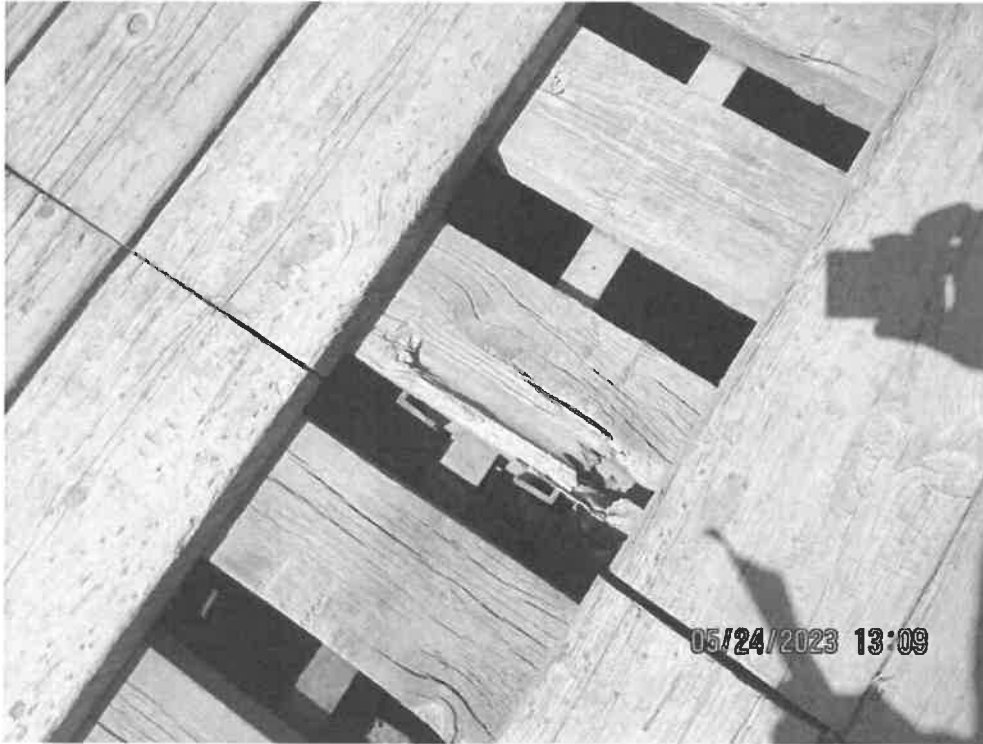
Photo 25: Severe rot at deck timber.

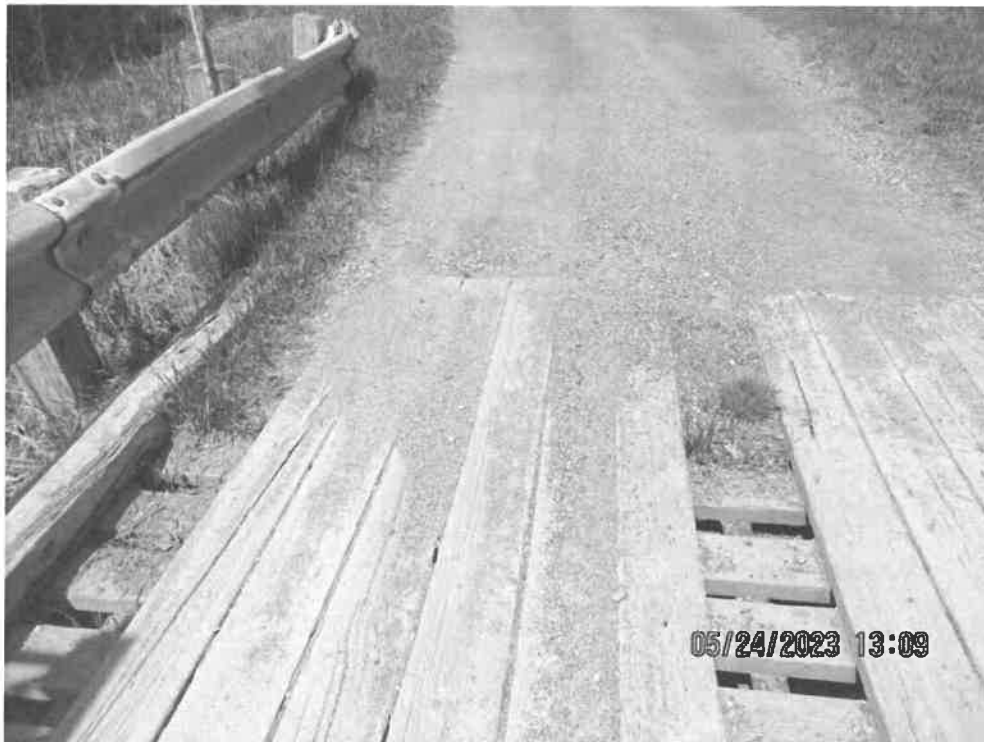
Photo 26: Gravel accumulation at approach (typ.).

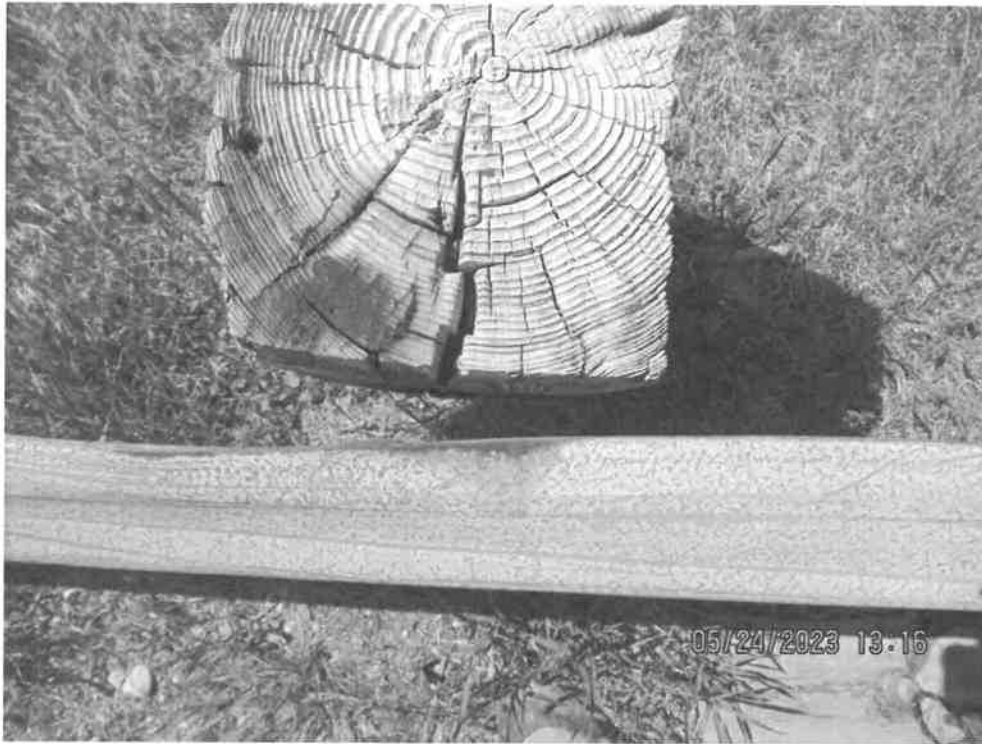
Photo 27: Missing thru bolt at guide rail south approach.

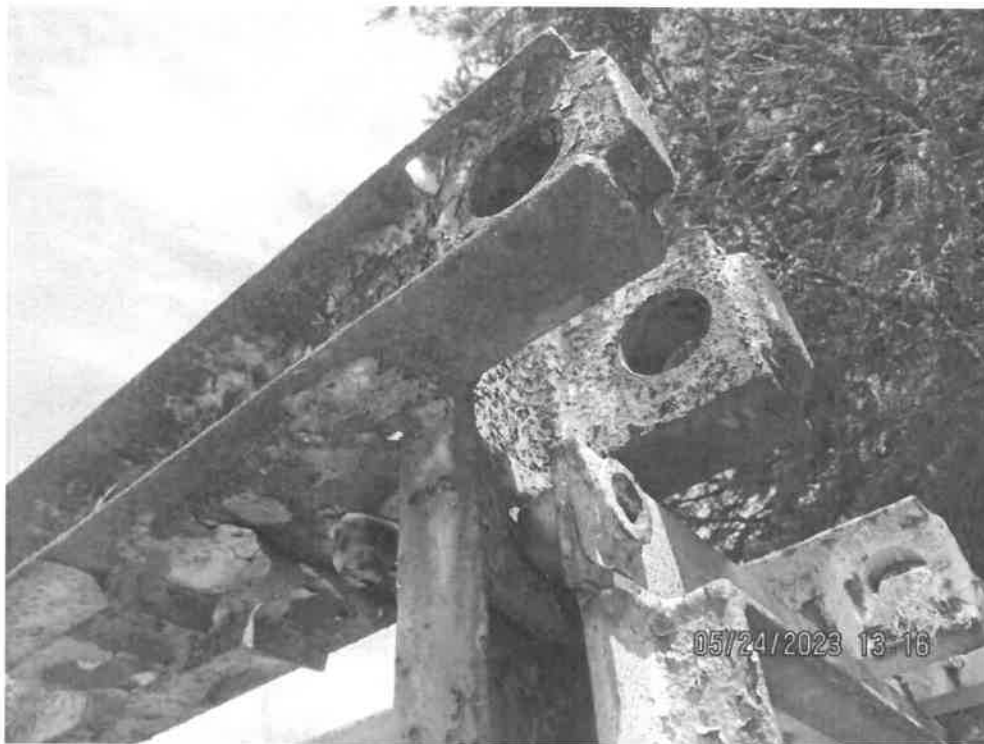
Photo 28: Missing truss brace bolt at southeast corner.

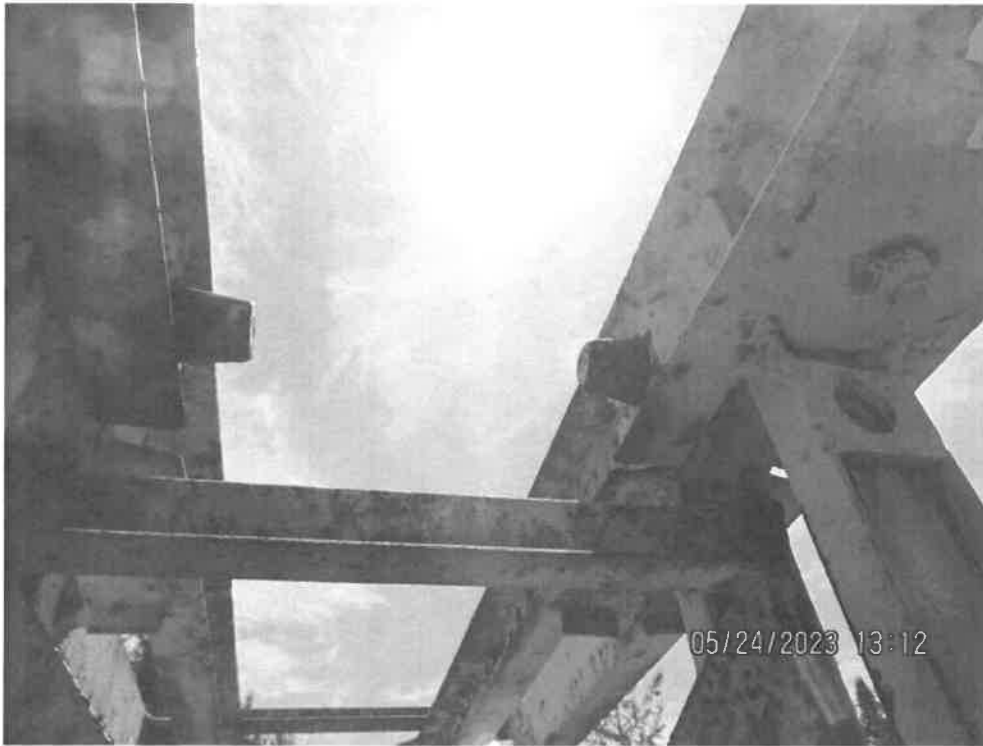
Photo 29: Missing cotter pins at panel pins (typ.).

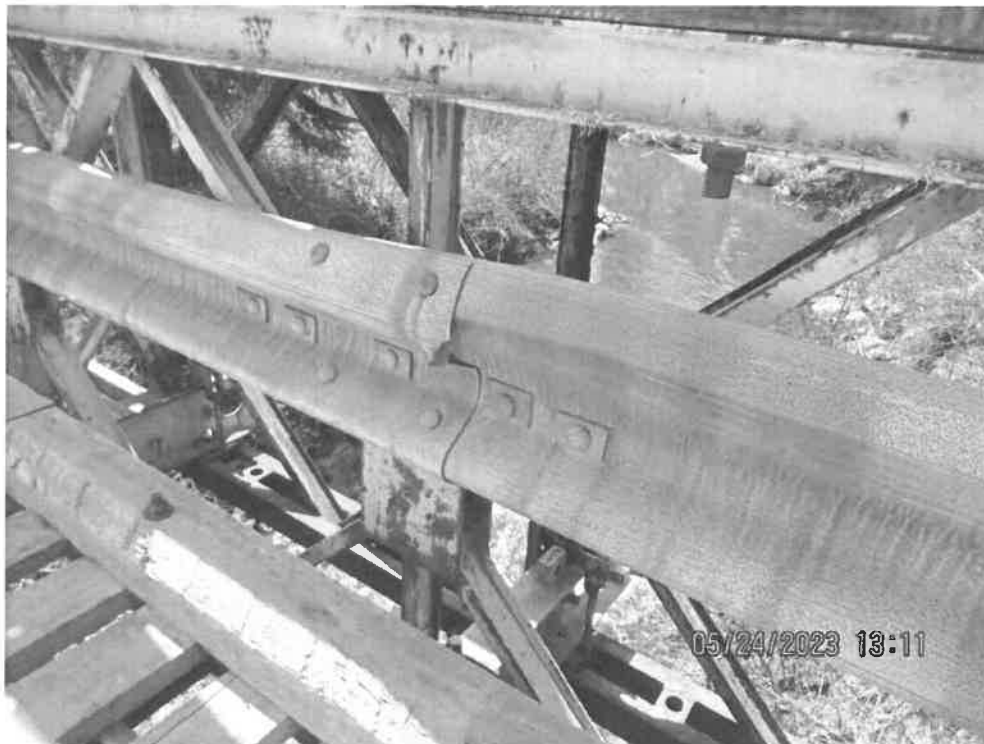
Photo 30: Impact damage at curb and guide rail.
