**APPENDIX E**  
**Red Rock Wastewater Treatment Plant Condition**  
**Assessment**

Township of Red Rock

# **Red Rock Water Pollution Control Plant Review of Existing Facility Technical Memorandum**

February 2010

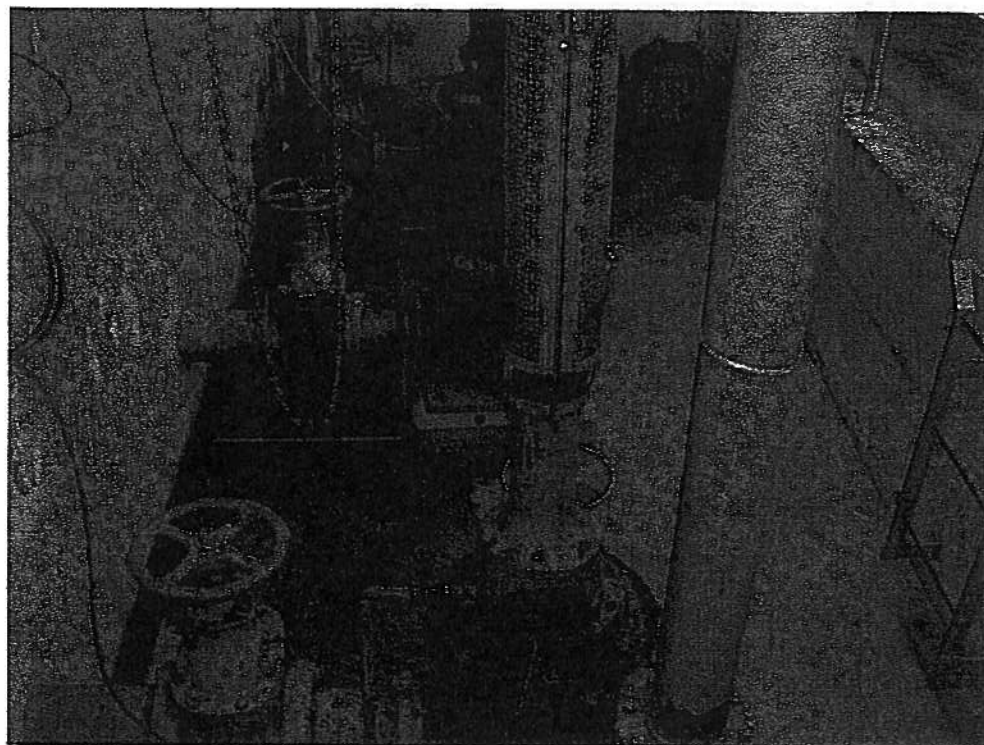
**Photograph 8. Raw Sewage Pumps**

The raw sewage pumps are constant speed bottom section type sewage pumps with shaft drives. The flow from the raw sewage pumping station is controlled via a hydraulic butterfly type control valve located downstream of the raw sewage pumps. Typically butterfly valves are not used in sewage applications as the disk is prone to clogging by capture of rags or other material.

The raw sewage pumps appear to be in relatively good condition; however, they are 30 years old and likely require a major rebuild to upgrade the impellers, wear rings and other components. Two of the three motors for the raw sewage pumps have been replaced over the years. Two of the rotating elements have been changed in the last 10 years or so)

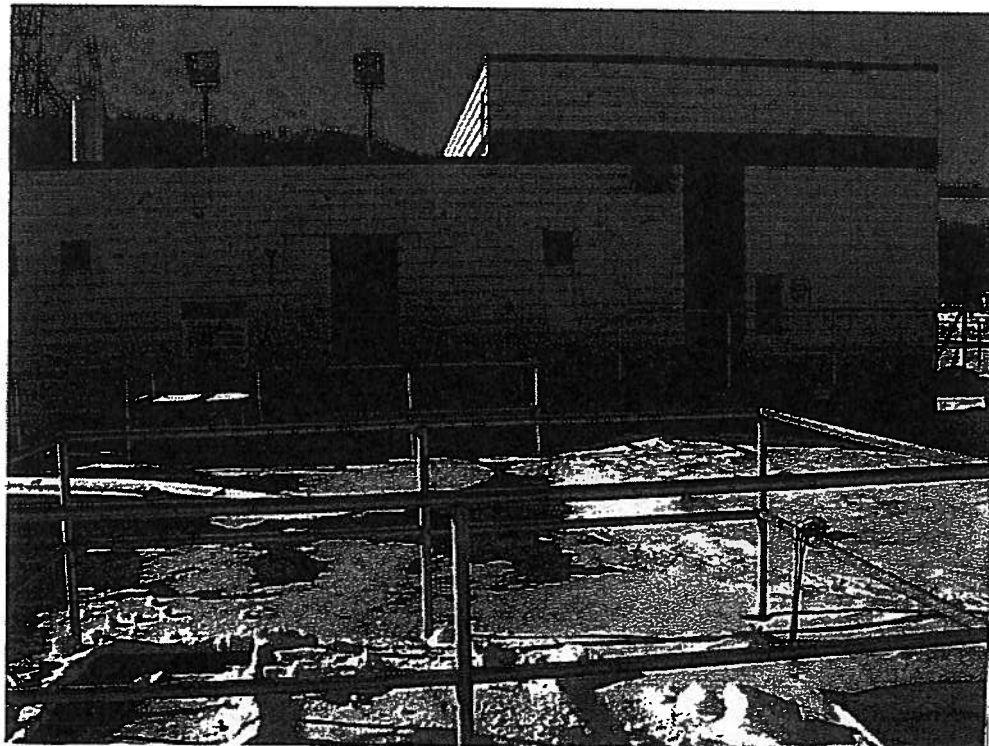
**Photograph 10. Primary Clarifiers**

There are two primary clarifiers, each 13.7 m (45 ft) long by 3.7 m (12 ft) wide a side water depth of 3.3 m (10.75 ft). With these dimensions, the primary clarifiers have a peak flow surface overflow rate of 83 m<sup>3</sup>/m<sup>2</sup>/day. The MOE guidelines require primary clarifiers to have a peak overflow rate of 60 – 80 m<sup>3</sup>/m<sup>2</sup>/day for clarifiers not handling activated sludge. Thus, the existing primary clarifiers are above the maximum MOE guideline overflow rates.
