Brompton Road Reconstruction & Watermain Relining

Spring/Summer 2022 - Reconstruction of
Brompton Rd. and watermain relining along
Newton Ave., Stadler Ave., and Frost St.

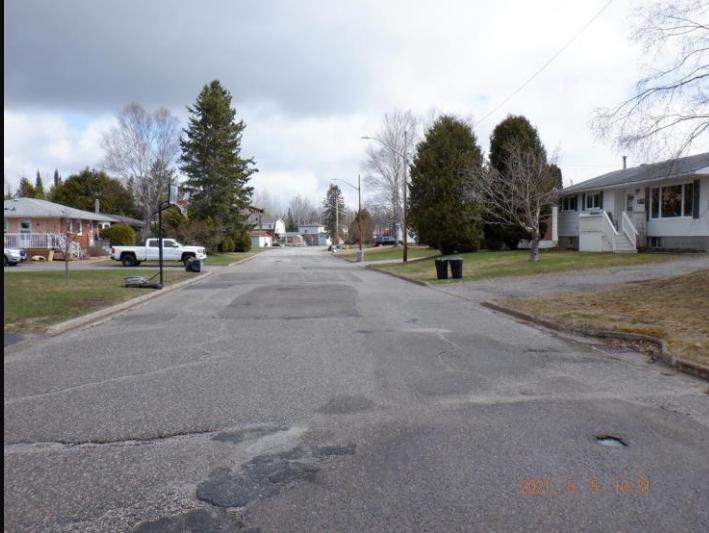
Asphalt pavement along
Brompton Road

- The asphalt pavement along Brompton Road is generally in poor condition.
- The concrete curb and gutters along Brompton Road are generally in poor to fair condition.

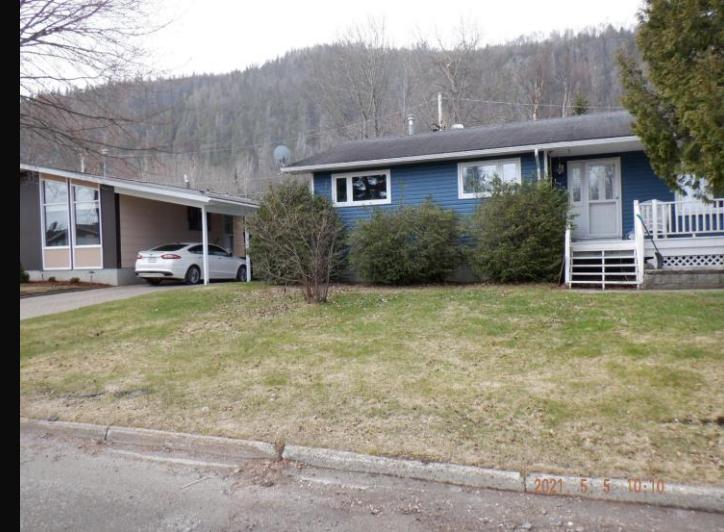
Deterioration of curb and gutter

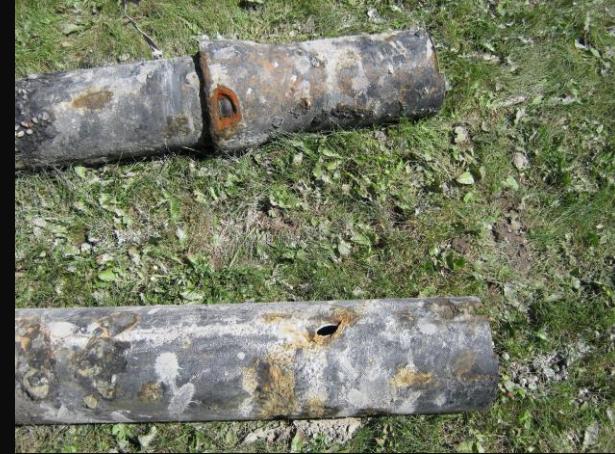
Severe corrosion and perforations at the existing pipe (2012)

- Residents near the intersection of Stadler Avenue and Frost Street frequently report low water pressure.
- In 2012, a section of watermain along Frost Street was replaced. This section of watermain was in poor condition and contained severe corrosion and perforations. The watermain in this area is the same age as the watermains along Stadler Avenue, Frost Street and Newton Avenue.
- Water quality is poor along Brompton Road, Stadler Avenue, Frost Street, and Newton Avenue.
- The watermain at the intersection of Rouse and Brompton is shallow and the intersecting water service lines have experienced freezing in the winter.
- A bleeder station exists at the end of Brompton Road to ensure water quality at the dead-end watermain. The bleeder station runs continuously, and a significant volume of water treated is wasted annually.

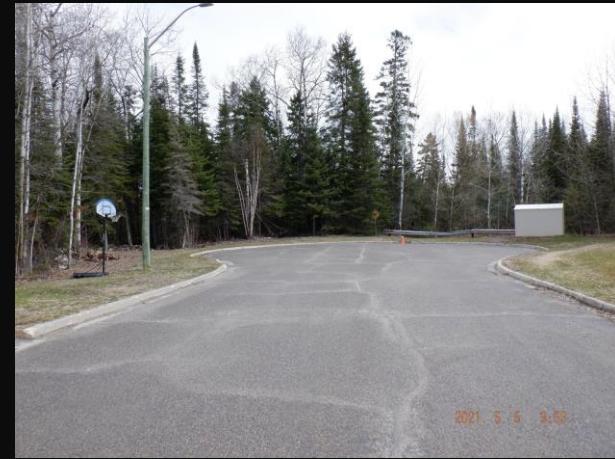
Bleeder station at the end of Brompton Road.

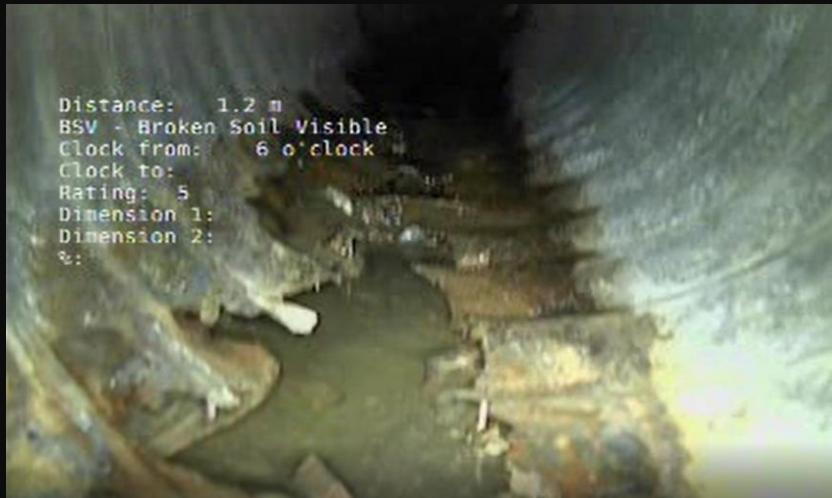
Severe corrosion and section loss at barrel.

- The sanitary sewer main is too flat. Sanitary sewer flow is impeded.
- The sanitary sewer and stormwater pipes at various locations are in poor condition.
- Perforations, standing water, and joint leaks at the stormwater pipes between various storm manholes.
- The storm manholes are generally in poor condition.

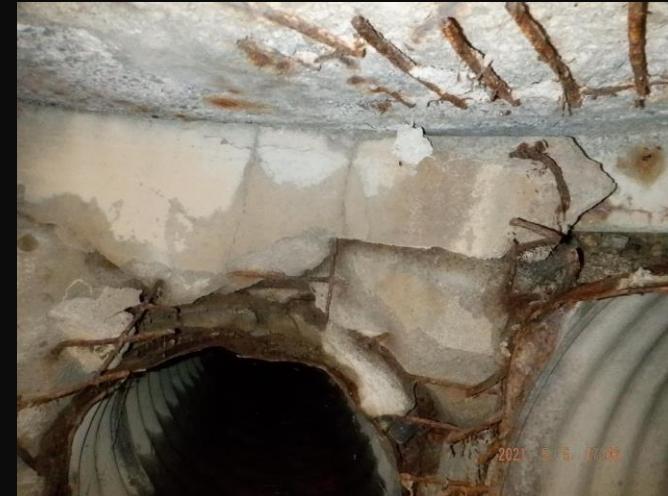
Storm sewer manhole in poor condition throughout

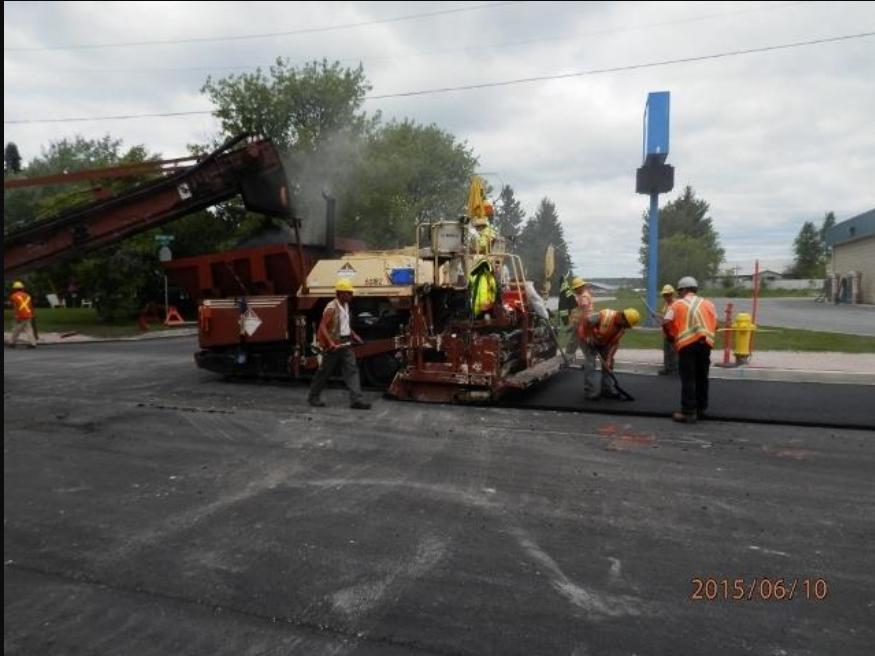
- Replace asphalt complete with new granular base/subbase along Brompton Road within the limits of the project.
- Replace all curb and gutter along Brompton Road within the limits of the project.

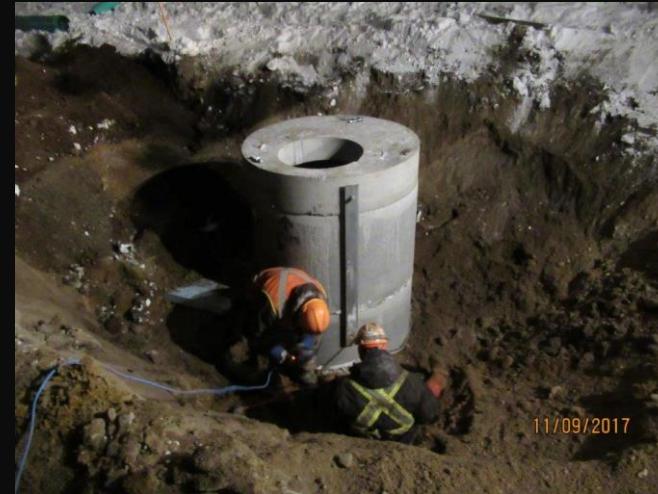
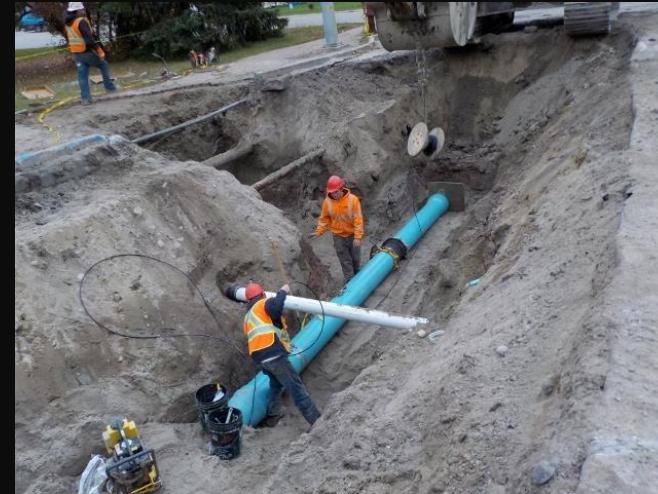
- Repair/replace existing storm/sanitary manholes and pipes.
- Replace sanitary and storm sewer lines to increase slope and improve flow.

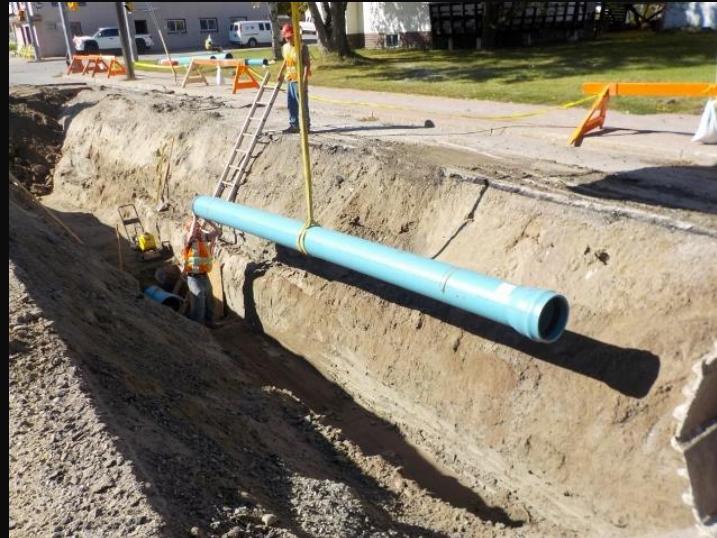
New watermains

- Replace the existing cast iron watermain along Brompton Road with a new PVC watermain.
- Provide a PVC watermain extension from Stadler Avenue to Brompton Road along the easement/trail and a watermain looping solution to the dead-end at Brompton Road to eliminate bleeder station.
- Reline watermains along Stadler Avenue, Frost Street, and Newton Avenue.

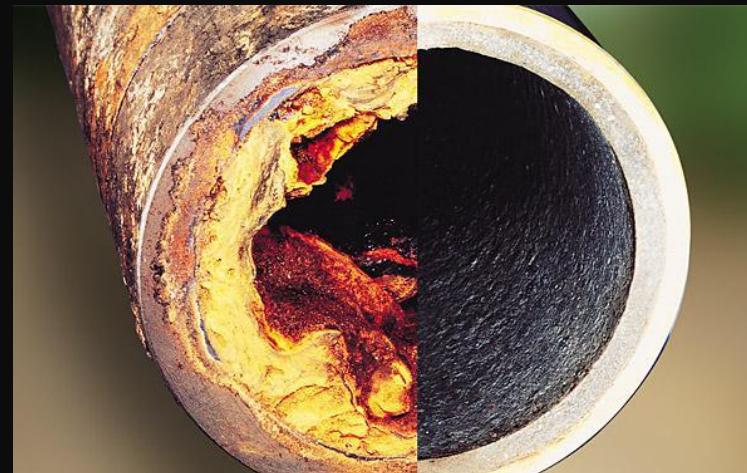
Pipe relining

- After considering various options, the watermains should be relined using cement mortar.
- Cement mortar lining continues to be used by other municipalities in the region as a cost-effective method to extend the life of watermains vs replacement.

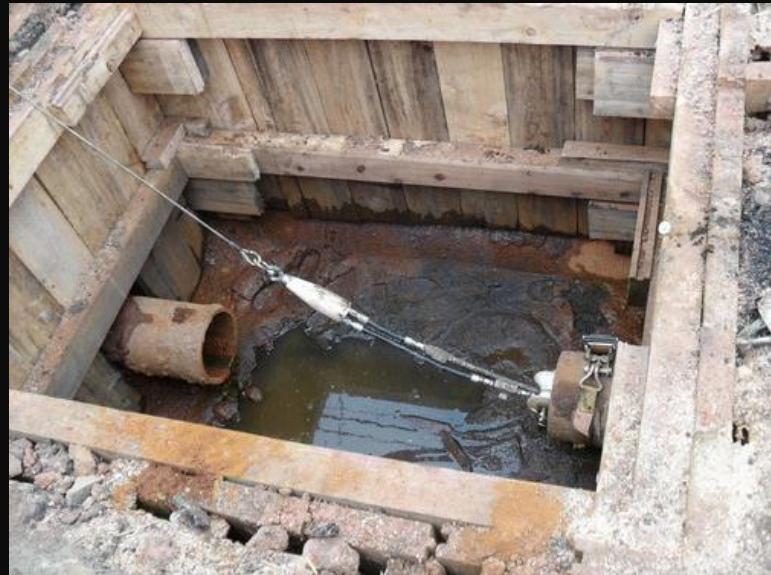
Watermain Relining Procedure:

1. Access pits are excavated at each end of the pipe to be relined.
2. The watermain is cut at each end.
3. The watermain is thoroughly cleaned.
4. A CCTV camera inspection is done inside the watermain.
5. Cement mortar lining is sprayed around the inside of the pipe and trowelled smooth.
6. The pipe is flushed, disinfected, and pressure tested.
7. Water service lines are cleared by back flushing.

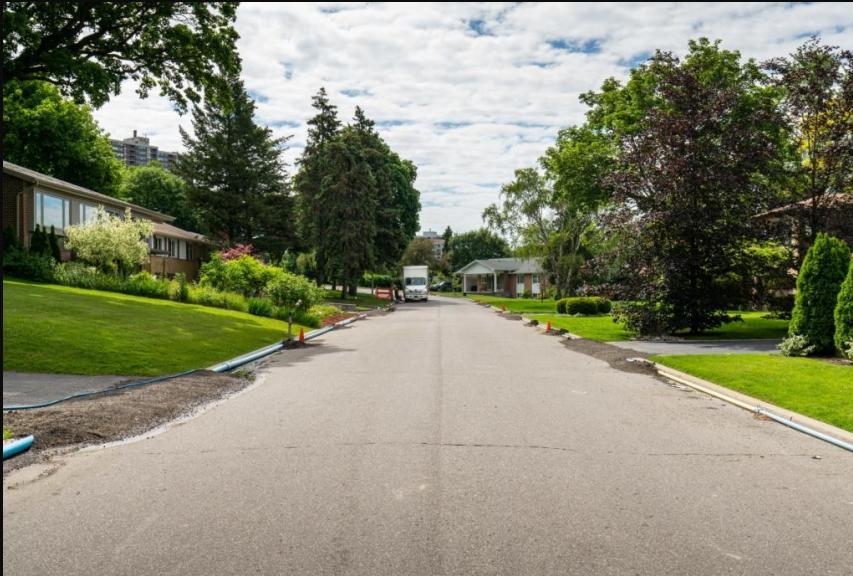
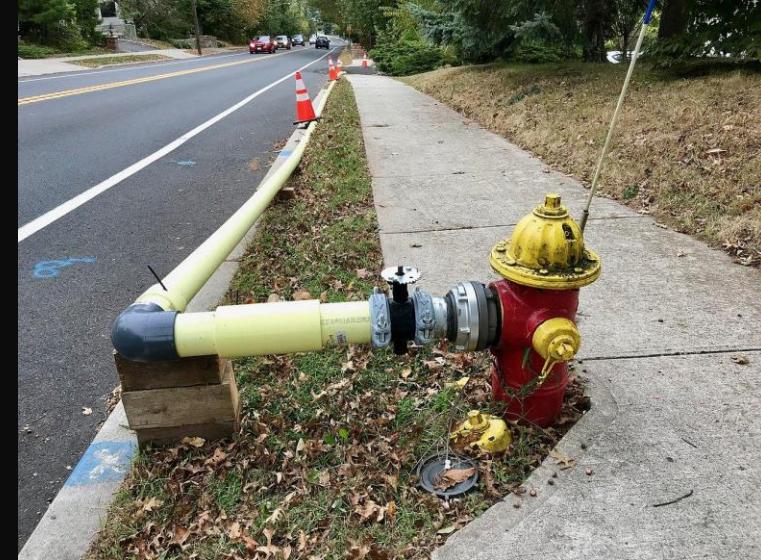
- Temporary water supply will be provided to residents by connecting to hose bibs for the duration of watermain replacement/relining.
- The temporary water supply line will run along the gutter and be covered by cold mix asphalt at each driveway.
- The temporary water system will be flushed, disinfected, and tested to ensure quality.
