Bi-annual Inspection Four Bridges One Culvert

**FOR THE
TOWNSHIP OF RED ROCK**

Ref. No. JML2023013

Reference: **Bi-Annual Inspection Four Bridges One Culvert**

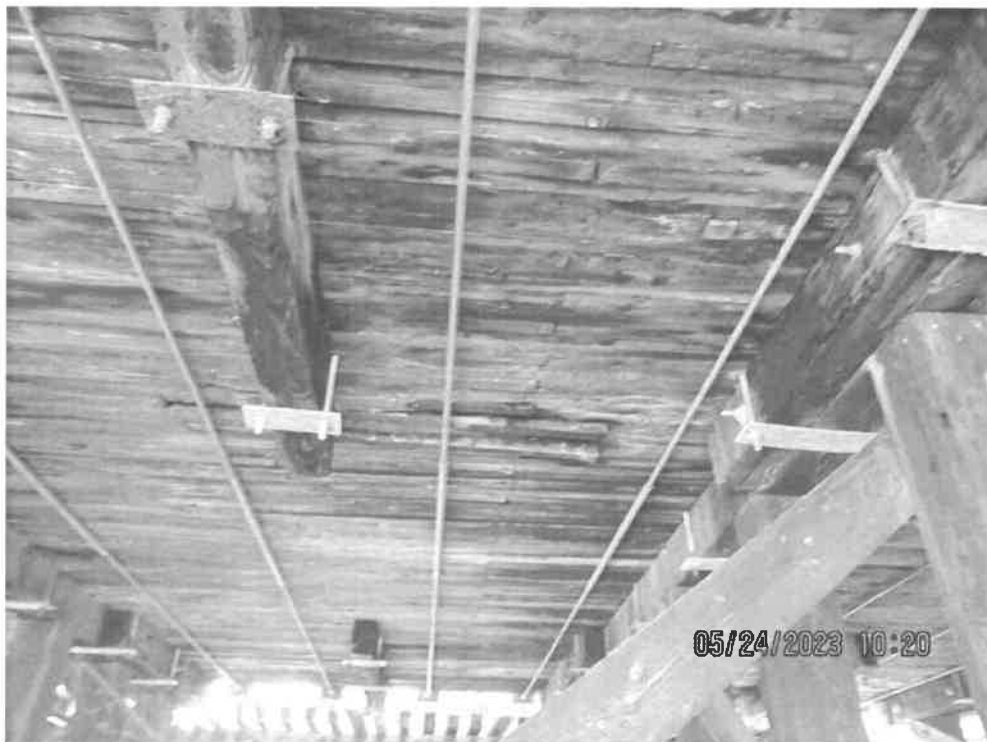
Photo 30: Severe separation of deck timbers (typ.).

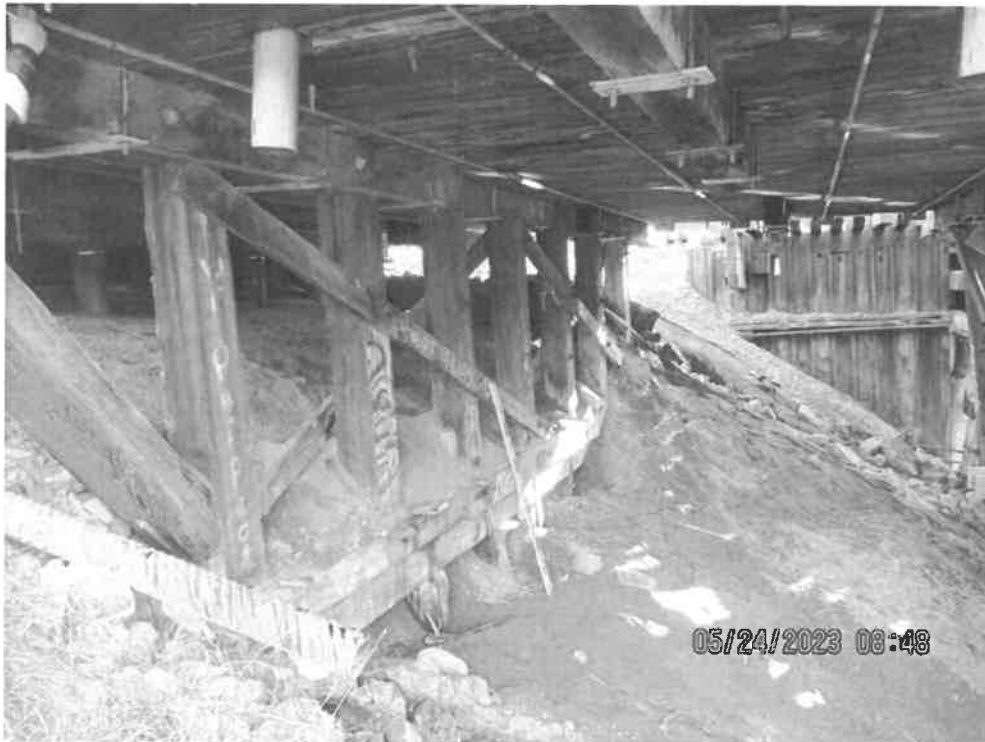
Photo 34: Severe erosion at north embankment.

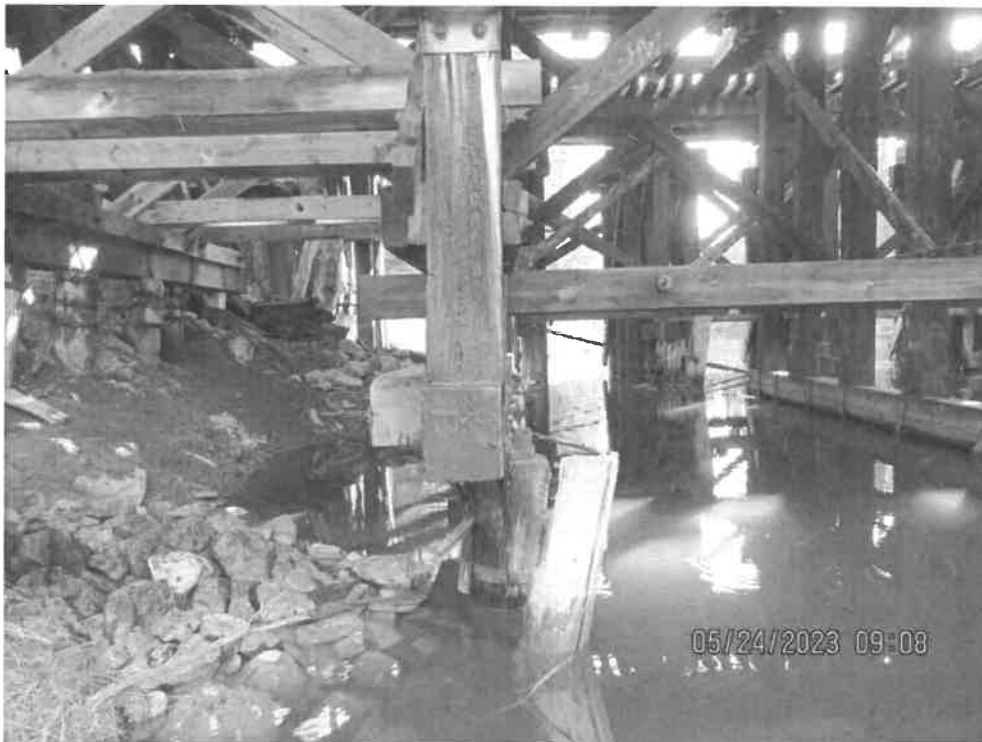
Photo 38: Pile not in full contact with pile cap (typ.).
