Bi-annual Inspection Four Bridges One Culvert

**FOR THE
TOWNSHIP OF RED ROCK**

Ref. No. JML2023013

Reference: **Bi-Annual Inspection Four Bridges One Culvert**

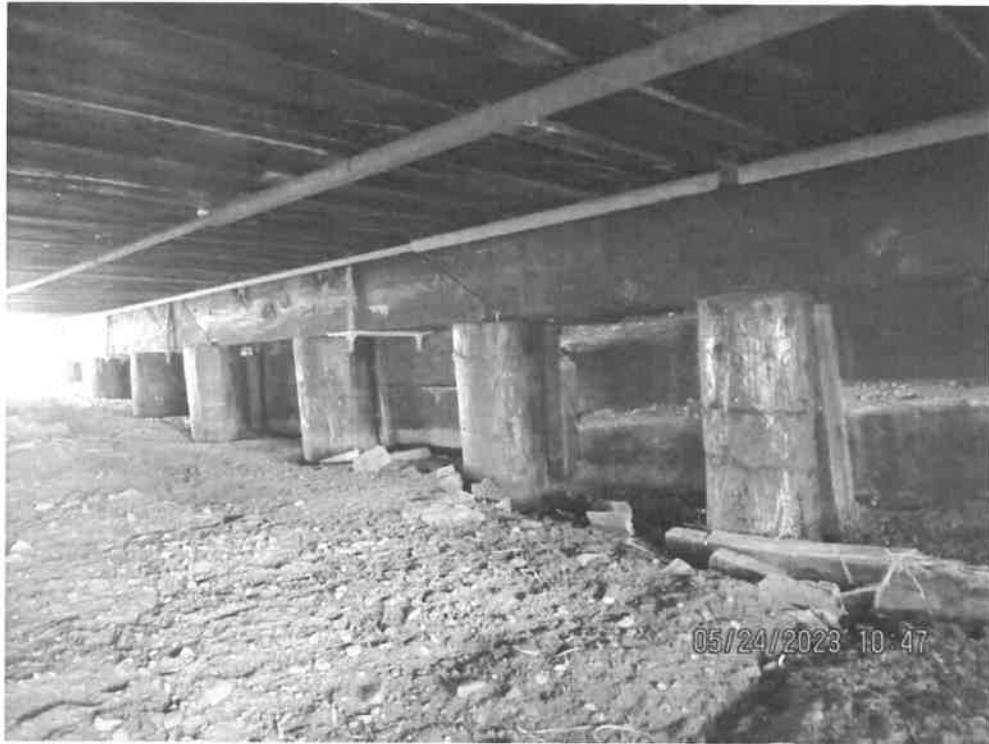
Photo 13: South abutment.

Fill loss was observed at the west side behind the south abutment wall.
